North East Link Project

EES Inquiry and Advisory Committee (IAC)

Statement of landscape and visual amenity evidence

Stephen Schutt of Hansen Partnership Pty Ltd.

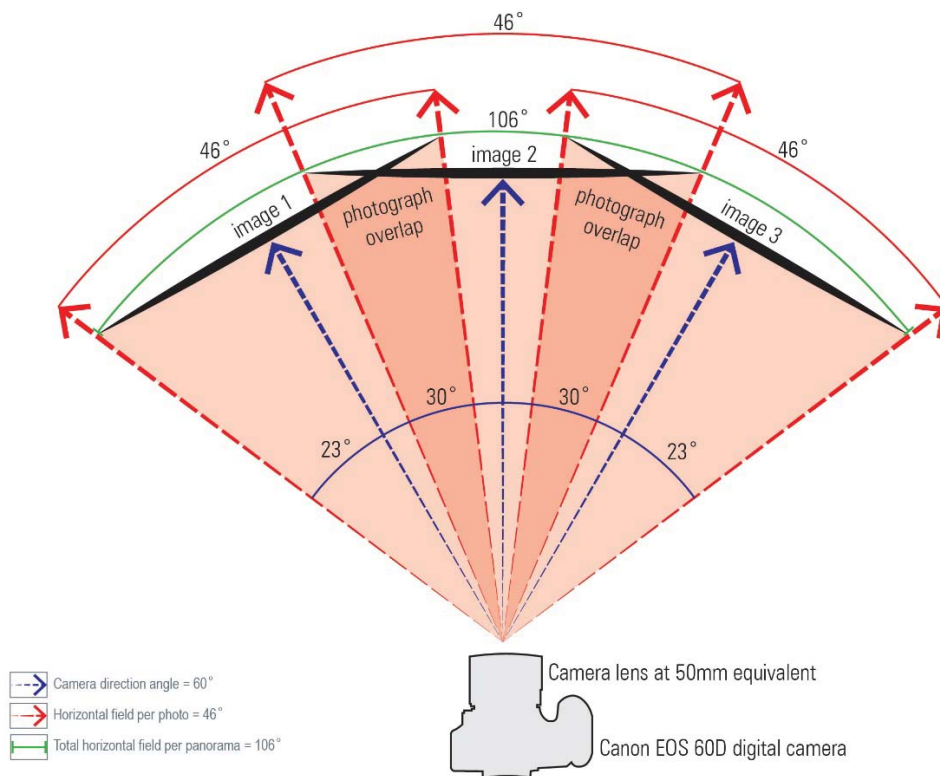
Figure 1: Diagrammatic representation of the composition of a panoramic photo to provide a horizontal field of view in the order of 100 degrees.

33. I note that many of the ‘photomontages’ provided within *Technical Report H* as the basis for demonstrating the visual impact of the Project do not represent a horizontal field of view of 80 or 100 degrees. It is my estimation that they represent a horizontal field of view of roughly half that extent. To demonstrate, the ‘photograph of existing conditions’ at Figure 3 below is a reproduction of Viewpoint 58 in EES *Technical Report H*, which – like every other Viewpoint in the EES *Technical Report H* is used as the basis for the preparation of subsequent ‘Photomontage’ images. By comparison, the panoramic photo in Figure 3 on the following page was taken by a Landscape Architect employed at Hansen Partnership, at a location estimated as being within very close proximity to Viewpoint 58 within *Technical Report H*. The panoramic photo prepared by my office utilised a full-frame digital camera with a 50mm lens, with a series of photos joined to form a panoramic view which comprises a horizontal field of view in the order of 106 degrees, consistent with the diagram provided in Figure 1 above.

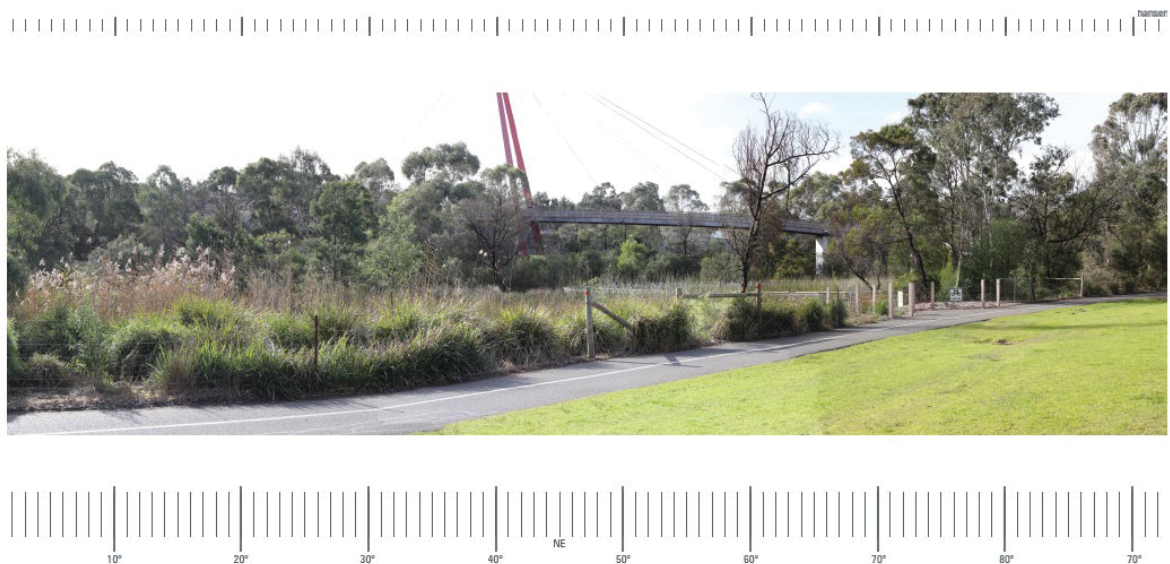
Figure 3: Appendix A - Photomontage 2 Existing View from Koonung Creek Wetlands Elgar Park, facing north-east towards proposed bridge and noise wall

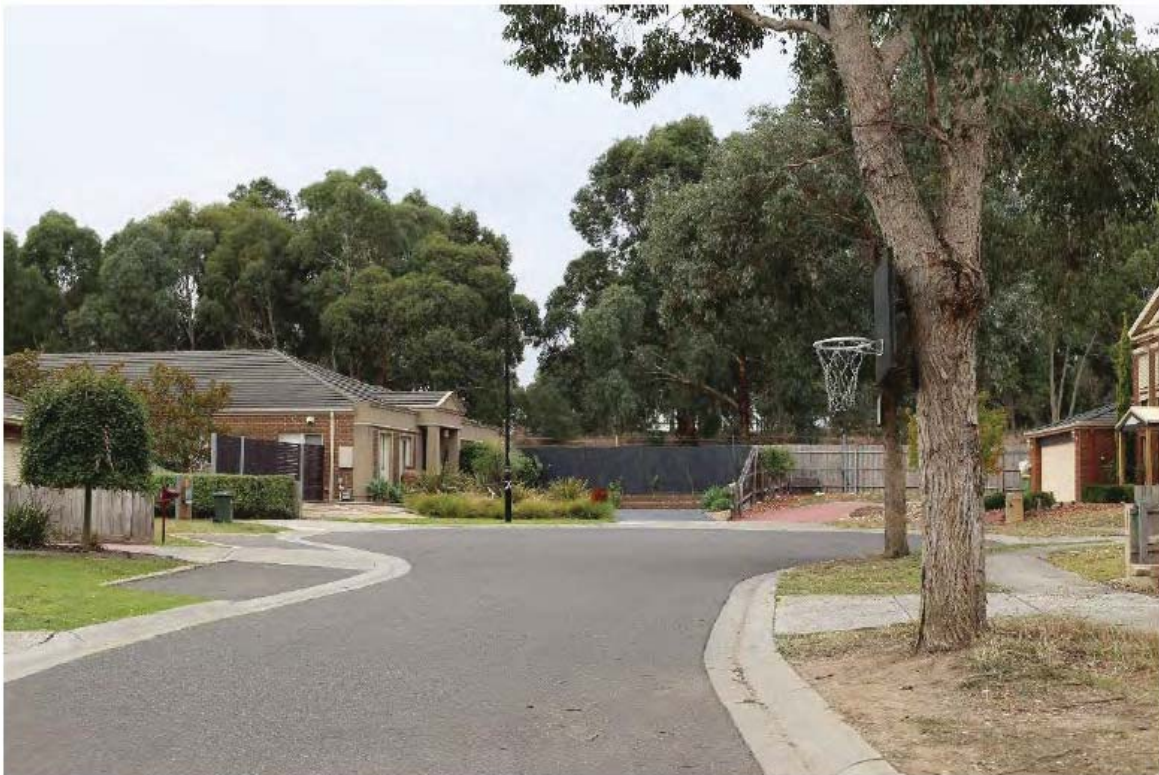
Figure 4: Technical Report H - Photo 9-45 'VP1 - Existing view looking north'

40. The rationale for the selection of this viewpoint is not stated. It is unclear whether this viewpoint is intended to be representative of broader impacts, and if so what the likely extent of those broader impacts is.
41. The 'existing view' shown in *Photo 9-45* within *Technical Report H* does not represent an 80-degree horizontal field of view, and as such neither adequately represents the 'human eye' view extent from this location or the extent to which that view is likely to be impacted by the project.

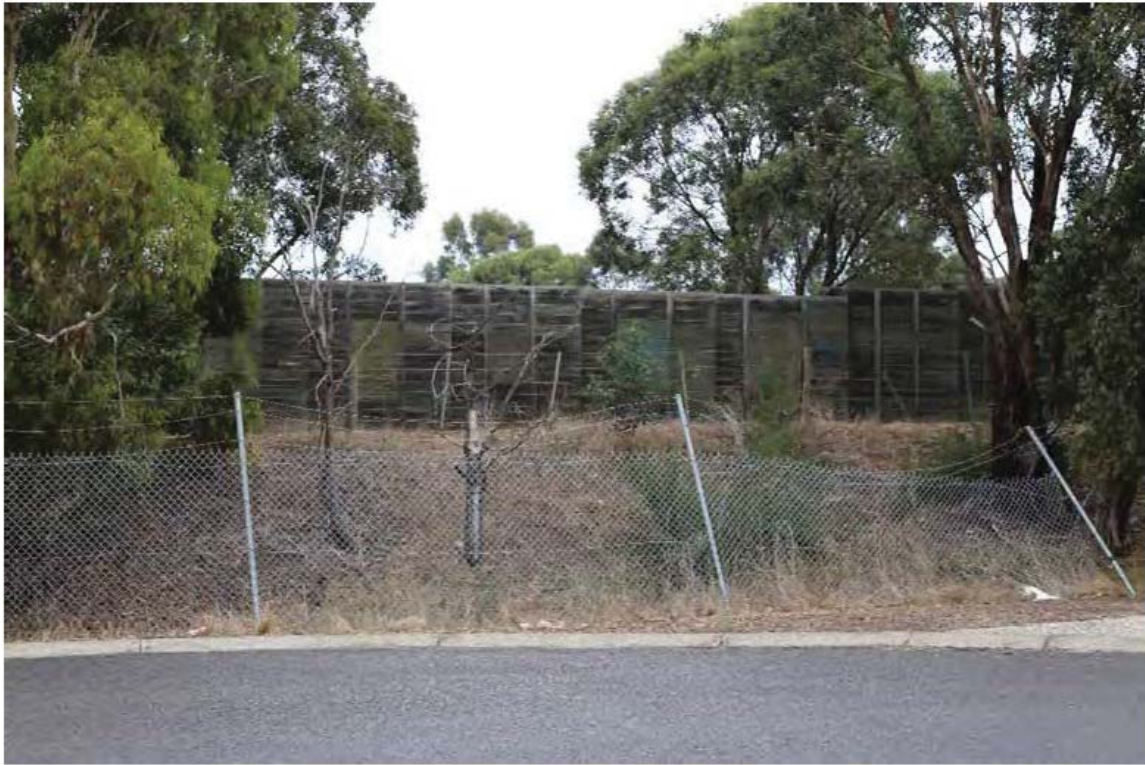
Figure 5: Technical Report H - Photo 9-46 'VP2 - Existing view looking south'

46. The rationale for the selection of this viewpoint is not stated. It is unclear whether this viewpoint is intended to be representative of broader impacts, and if so what the likely extent of those broader impacts is.
47. The 'existing view' shown in *Photo 9-46* within *Technical Report H* does not represent an 80-degree horizontal field of view, and as such neither adequately represents the 'human eye' view extent from this location or the extent to which that view is likely to be impacted by the project.

48. The assessment makes references to the visual impact on the viewpoint, but fails to consider the visual impact on the realigned shared use path, which will likely experience significantly greater foot and bicycle traffic than the selected viewpoint within the road carriageway of Killarney Ridge, and as illustrated in *Figure 9-113 VP2 – Landscape treatment section view east*, and by virtue of its close proximity to the proposed 7-metre high noise wall will not benefit from any visual impact mitigation through proposed buffer planting.
49. On the basis of the above, it is my opinion that the assessment of visual impact at Viewpoint 2 is misleading as it fails to represent the impact on the shared use path and as such should not be relied upon as a means of understanding the extent of visual impact expected in this location as a result of the project.

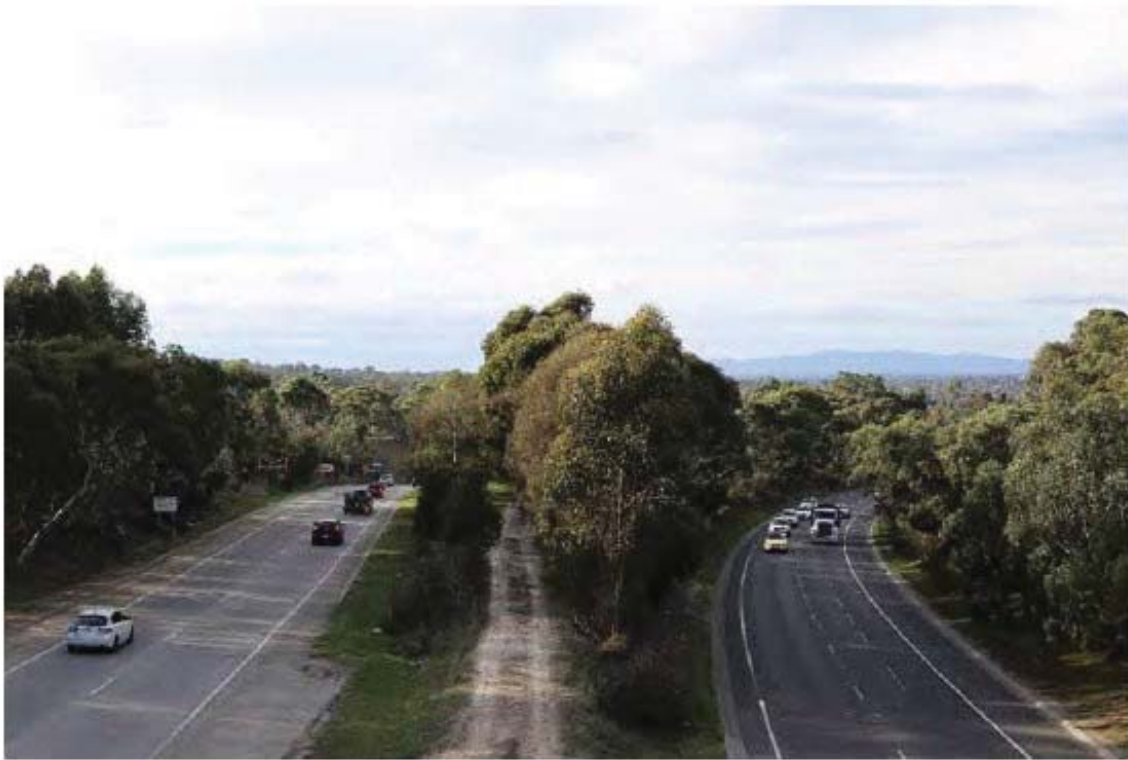
Figure 6: Technical Report H - Photo 9-47 'VP3 - Existing view looking south-east'

50. The rationale for the selection of this viewpoint is not stated. It is unclear whether this viewpoint is intended to be representative of broader impacts, and if so what the likely extent of those broader impacts is.
51. The 'existing view' shown in *Photo 9-47* within *Technical Report H* does not represent an 80-degree horizontal field of view, and as such neither adequately represents the 'human eye' view extent from this location or the extent to which that view is likely to be impacted by the project.

52. The rationale for the selection of this viewpoint - in a location where the assessment observes that "*viewer sensitivity would be low*" is questionable given that the nearby shared use path is arguably at significantly greater risk of detrimental visual and landscape impacts.

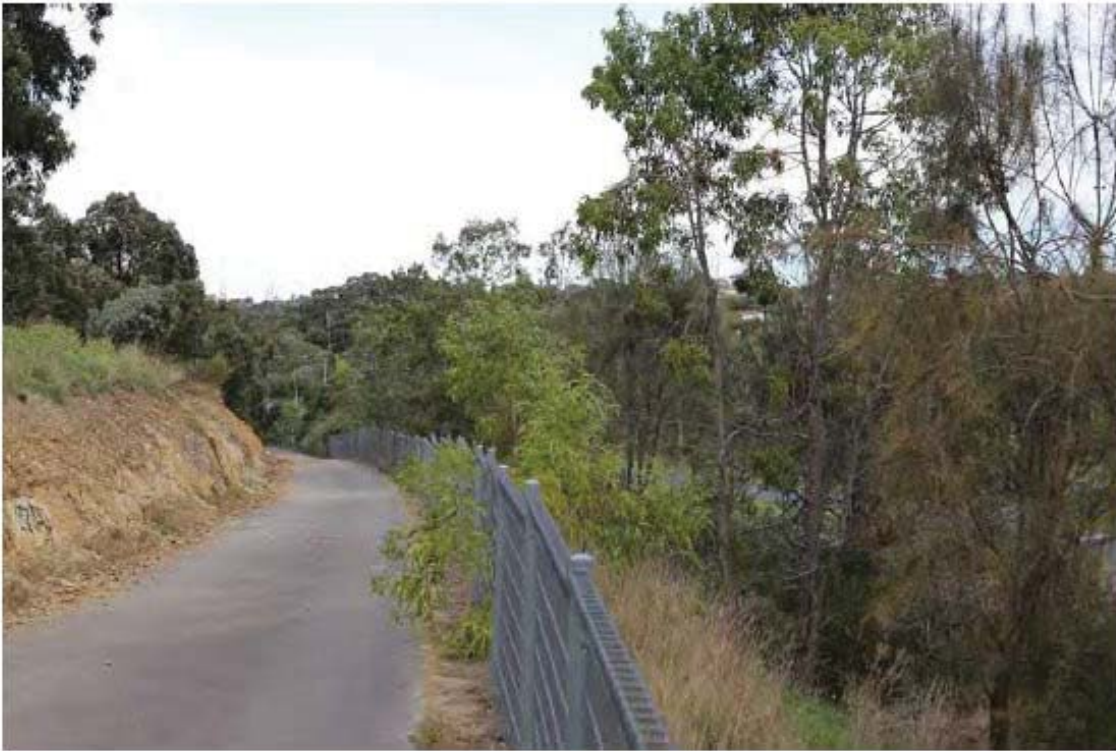
Figure 7: Technical Report H - Photo 9-49 'VP5 - Existing view looking south-west'

57. The 'existing view' shown in *Photo 9-49* within *Technical Report H* does not represent an 80-degree horizontal field of view, and as such neither adequately represents the 'human eye' view extent from this location or the extent to which that view is likely to be impacted by the project.

60. On the basis of the above, it is my opinion that the assessment of visual impact at Viewpoint 5 is misleading as it fails to adequately assess the impact on the shared use path and as such should not be relied upon as a means of understanding the extent of visual impact expected in this location as a result of the project.

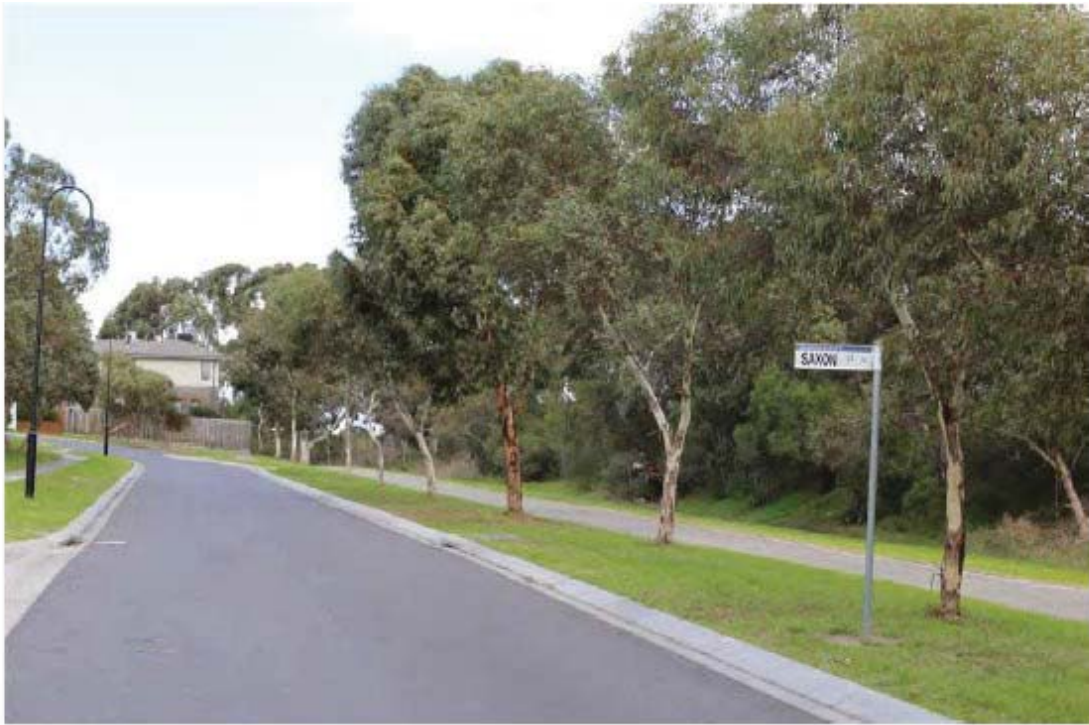
Figure 8: Technical Report H - Photo 9-52 'VP8 - Existing view looking south-west'

62. The 'existing view' shown in *Photo 9-52* within *Technical Report H* does not represent an 80-degree horizontal field of view, and as such neither adequately represents the 'human eye' view extent from this location or the extent to which that view is likely to be impacted by the project.

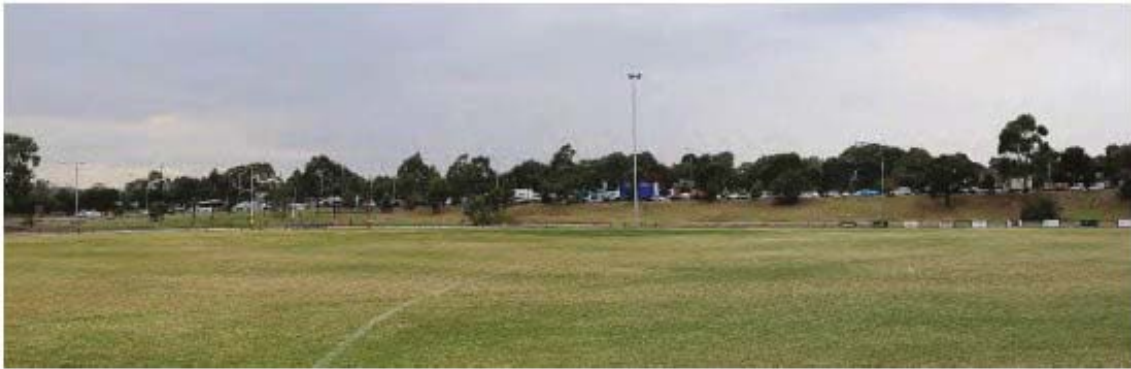
Figure 9: *Technical Report H - Photo 9-52 'VP9 - Existing view looking north-east'*

68. The rationale for the selection of this viewpoint is not stated. It is unclear whether this viewpoint is intended to be representative of broader impacts, and if so what the likely extent of those broader impacts is.
69. Helpfully, the 'existing view' shown in *Photo 9-53* and the photomontage views shown in *Figure 9-129* and *Figure 9-130* within *Technical Report H* do represent an 80-degree horizontal field of view, and as such adequately represent the 'human eye' view extent from this location and the extent to which that view is likely to be impacted by the project.

70. However, it is my opinion that the extent to which existing vegetation is shown retained and visible above proposed project elements is inaccurate and hence misleading. The vegetation in question is located immediately east of the existing Greensborough Road carriageways, between Greensborough Road and the Hurstbridge Railway Line, in an area which the *Map Book* identifies as being extensively-modified by the project. It is my expectation that much – if not all – of this vegetation will be removed, and that removal would likely result in a significantly-different photomontage, whereby the project infrastructure would not benefit from the 'visual softening' afforded by the canopy vegetation represented as being above the silhouette of the road infrastructure.

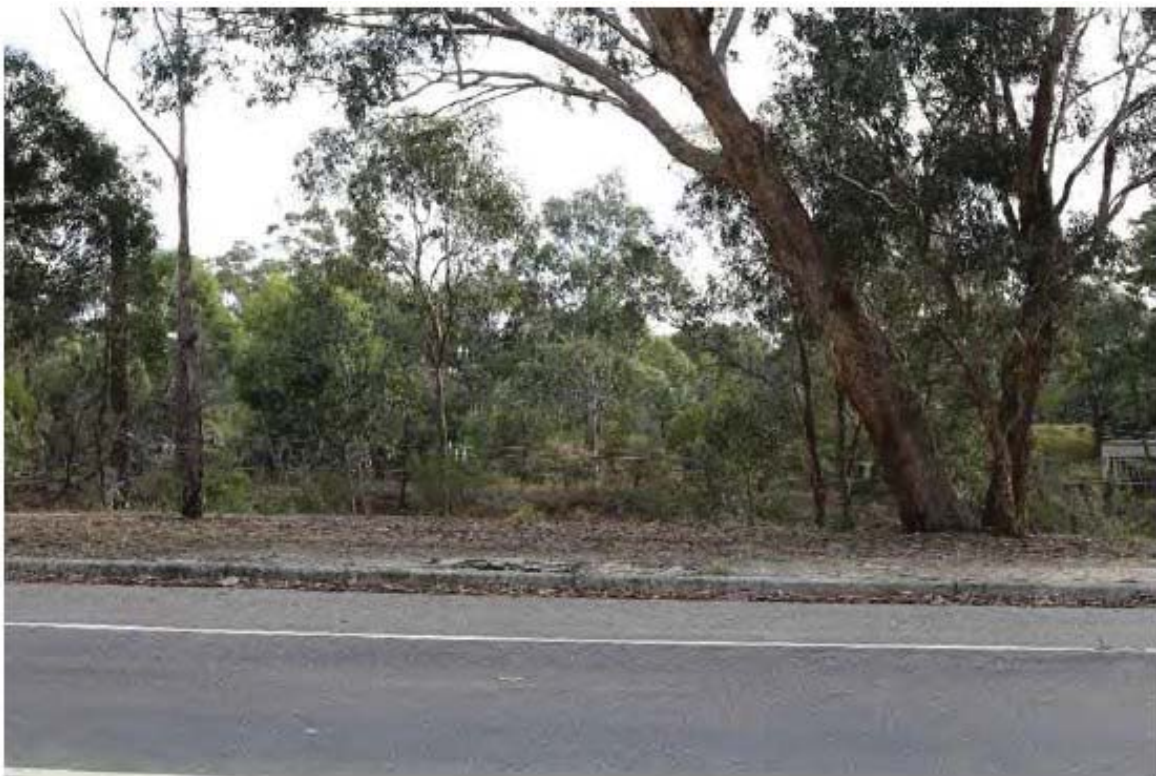
Figure 10: *Technical Report H - Photo 9-54 'VP10 - Existing view looking north-west'*

72. The rationale for the selection of this viewpoint is not stated. It is unclear whether this viewpoint is intended to be representative of broader impacts, and if so what the likely extent of those broader impacts is.
73. The 'existing view' shown in *Photo 9-54* within *Technical Report H* does not represent an 80-degree horizontal field of view, and as such neither adequately represents the 'human eye' view extent from this location or the extent to which that view is likely to be impacted by the project.

74. The assessment of "medium" visual impact at Year 0 is in my opinion inconsistent with the description of the proposed change, which describes the removal of all existing vegetation, the introduction of a 10-metre high shared use overpass and a 7-metre high noise wall within 15 metres of the viewpoint and no opportunity for landscaping as a means of mitigating the resultant visual impact.
75. On the basis of the above, it is my opinion that the assessment of visual impact at Viewpoint 10 is poorly-conceived and as such should not be relied upon as a means of understanding the extent of visual impact expected in this location as a result of the project.

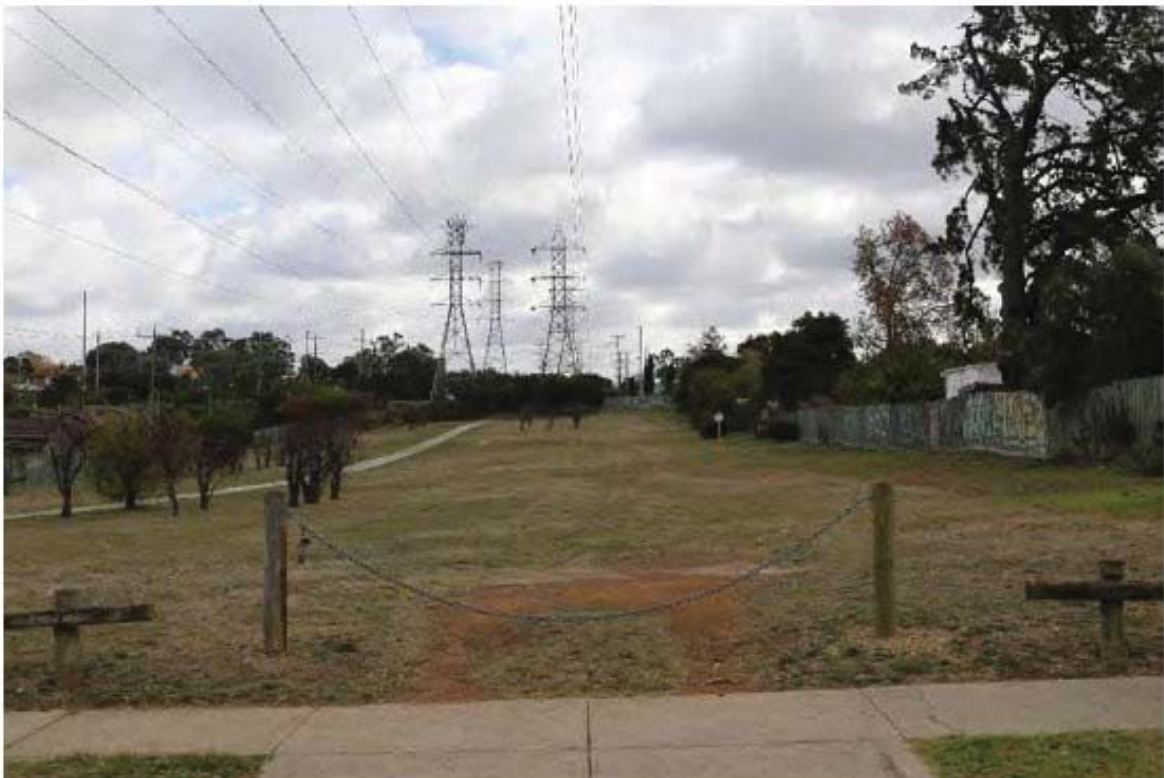
Figure 11: *Technical Report H - Photo 9-55 'VP11 - Existing view looking north-west'*

76. The rationale for the selection of this viewpoint is not stated. It is unclear whether this viewpoint is intended to be representative of broader impacts, and if so what the likely extent of those broader impacts is.
77. The 'existing view' shown in *Photo 9-55* within *Technical Report H* does not represent an 80-degree horizontal field of view, and as such neither adequately represents the 'human eye' view extent from this location or the extent to which that view is likely to be impacted by the project.

78. The assessment of "medium" visual impact at Year 10 relies upon proposed landscaping to partially screen the noise walls and the 10-metre high shared use overpass, however the *Urban Design Strategy* (at p. 39) notes that such landscaping – being located within the transmission line easement – is outside the project scope. Given this, it is unclear why the EES LVIA has assumed that such landscaping will be provided, and misleading that the assessment has relied upon this landscaping as a means of mitigating visual impacts resulting from the project.
79. On the basis of the above, it is my opinion that the assessment of visual impact at Viewpoint 11 is misleading and as such should not be relied upon as a means of understanding the extent of visual impact expected in this location as a result of the project.

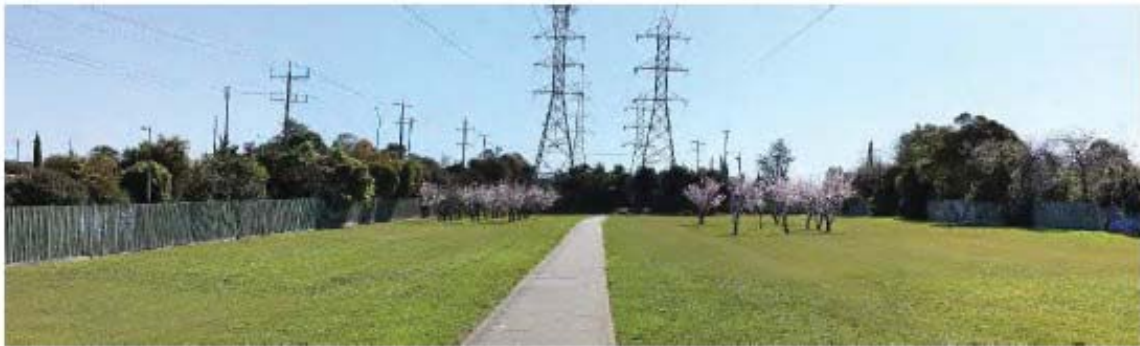
Figure 12: *Technical Report H - Photo 9-56 'VP12 - Existing view looking north-west'*

80. The rationale for the selection of this viewpoint is not stated. It is unclear whether this viewpoint is intended to be representative of broader impacts, and if so what the likely extent of those broader impacts is.
81. The 'existing view' shown in *Photo 9-56* and the photomontage views shown in *Figure 9-136* and *Figure 9-137* within *Technical Report H* do represent an 80-degree horizontal field of view, and as such adequately represent the 'human eye' view extent from this location and the extent to which that view is likely to be impacted by the project.

82. The assessment of "medium" visual impact at Year 10 relies upon proposed landscaping to partially screen the noise walls, however the *Urban Design Strategy* (at p. 39) notes that such landscaping – being located within the transmission line easement – is outside the project scope. Given this, it is unclear why the EES LVIA has assumed that such landscaping will be provided, and misleading that the assessment has relied upon this landscaping as a means of mitigating visual impacts resulting from the project.
83. On the basis of the above, it is my opinion that the assessment of visual impact at Viewpoint 12 is misleading and as such should not be relied upon as a means of understanding the extent of visual impact expected in this location as a result of the project.

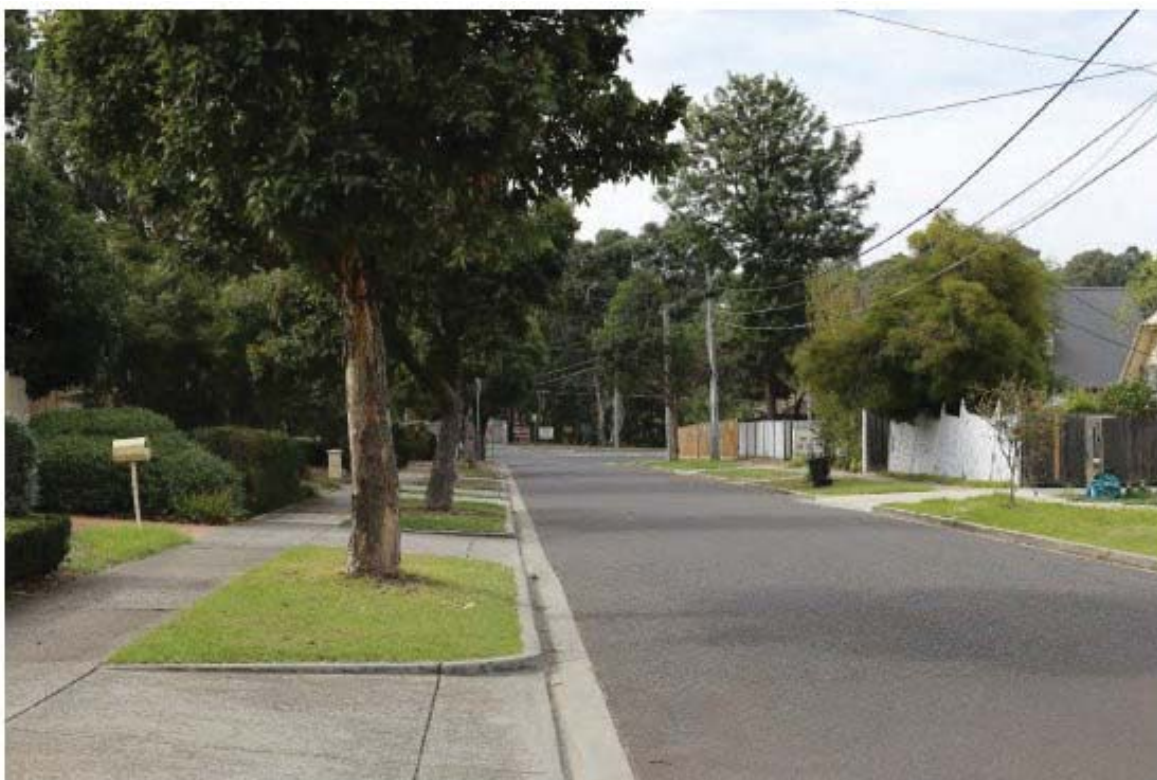
Figure 13: Technical Report H - Photo 9-62 'VP18 - Existing view looking east'

84. The rationale for the selection of this viewpoint is not stated. It is unclear whether this viewpoint is intended to be representative of broader impacts, and if so what the likely extent of those broader impacts is.
85. The 'existing view' shown in *Photo 9-62* within *Technical Report H* does not represent an 80-degree horizontal field of view, and as such neither adequately represents the 'human eye' view extent from this location or the extent to which that view is likely to be impacted by the project.

86. It is difficult to understand why a view location was selected in Fairlie Avenue when the location plan at *Figure 9-150* in *Technical Report H* shows that the next street south – Sydney Street – is only 100 metres away and provides a direct line of sight towards a proposed ventilation structure with an anticipated height in the order of 40 metres, based on my interpretation of relevant information provided in the Map Book. No such direct line of sight is available from Fairlie Avenue. The assessment acknowledges that:

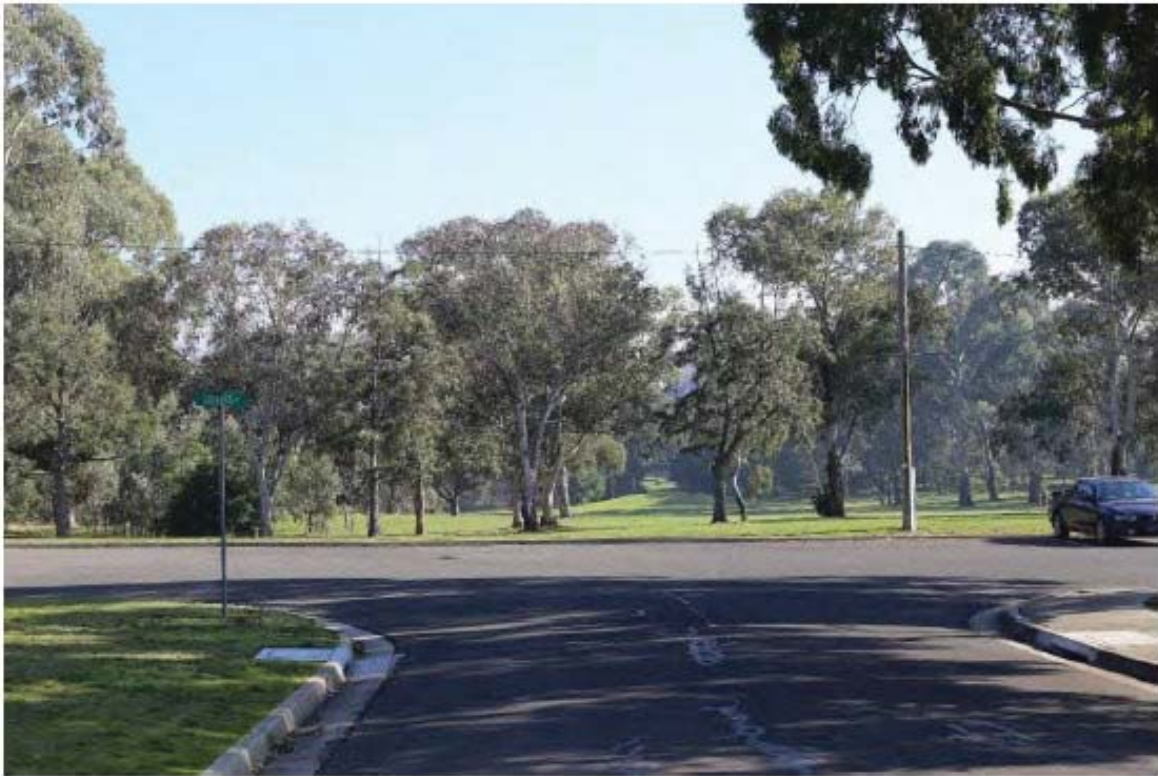
Figure 14: Technical Report H - Photo 9-63 'VP19 - Existing view looking west'

88. The rationale for the selection of this viewpoint is not stated. It is unclear whether this viewpoint is intended to be representative of broader impacts, and if so what the likely extent of those broader impacts is.
89. The 'existing view' shown in *Photo 9-63* within *Technical Report H* does not represent an 80-degree horizontal field of view, and as such neither adequately represents the 'human eye' view extent from this location or the extent to which that view is likely to be impacted by the project.

90. The assessment of the visual impact of the project at this location being “medium” appears to be reliant upon a number of assumptions, including:
- That existing vegetation which is retained will screen “the lower half” of the proposed ventilation outlet and associated ventilation building, although *Figure 9-153* and the *Map Book* appear to indicate substantial earthworks associated with alterations to existing ground level which would necessitate the removal of affected trees, and

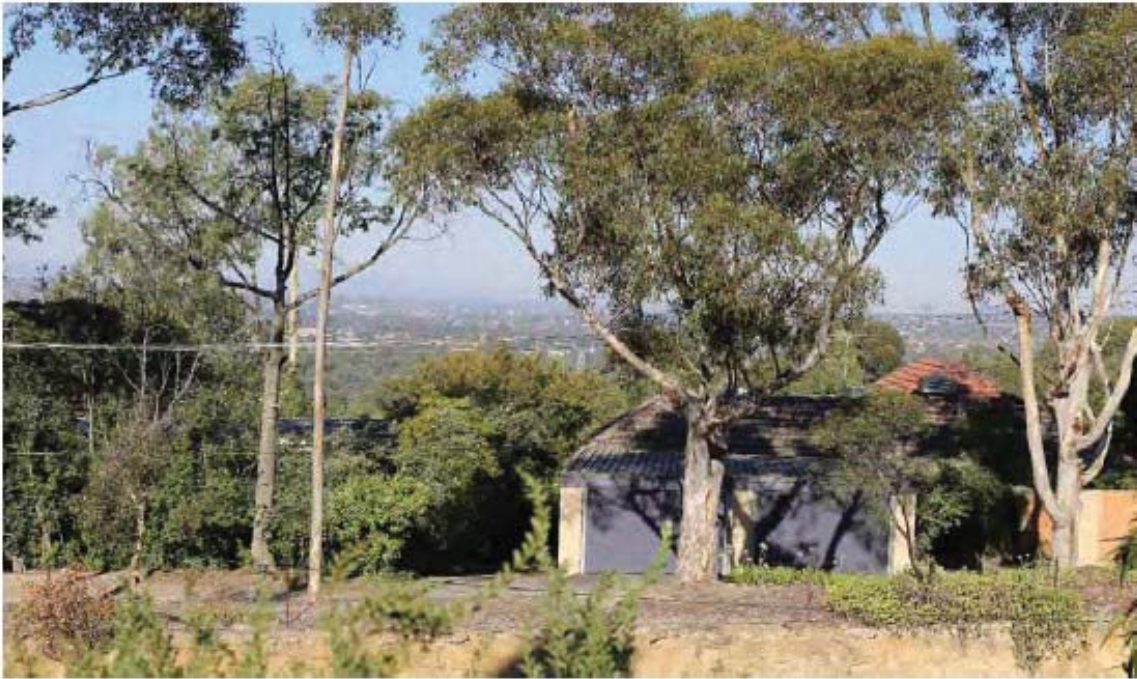
Figure 15: *Technical Report H - Photo 9-7 'VP31 - Existing view south-east'*

93. The 'existing view' shown in *Photo 9-7* within *Technical Report H* does not represent an 80-degree horizontal field of view, and as such neither adequately represents the 'human eye' view extent from this location or the extent to which that view is likely to be impacted by the project.

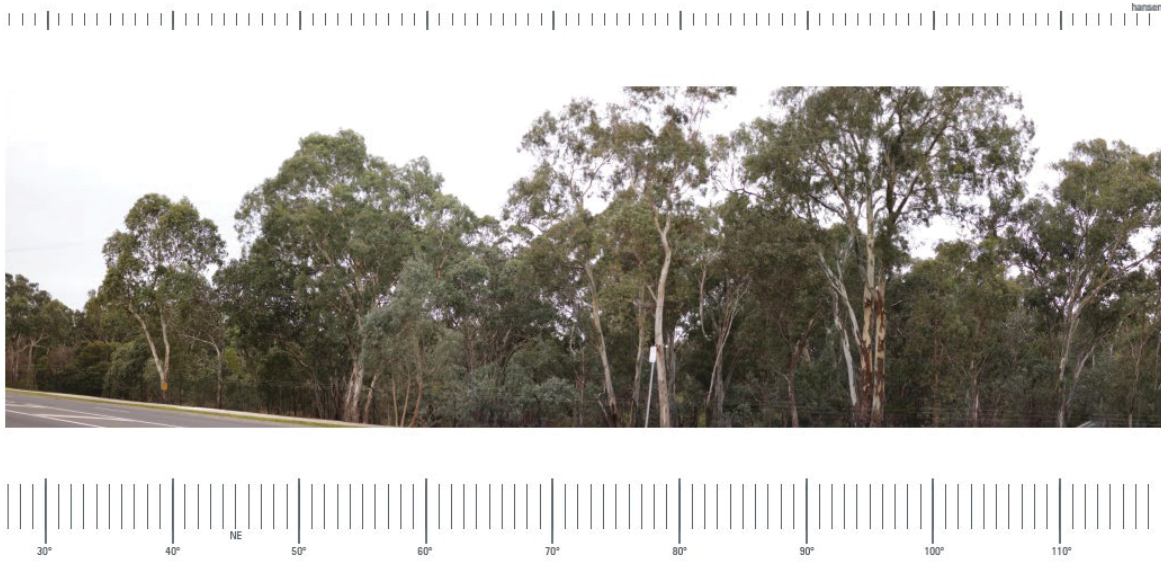
Figure 16: Appendix A - Photomontage 15 Existing View from corner Sydney Street and Greensborough Road, facing east towards proposed ventilation building

101. It is my opinion that a viewpoint located on the footpath on **Corner Sydney St and Greensborough Rd, Macleod** (*Refer Appendix A - Photomontage 15*), looking east toward the proposed ventilation building would show the full extent of visual impact experienced due to the proposed structure. This view is demonstrated in Figure 15 below.

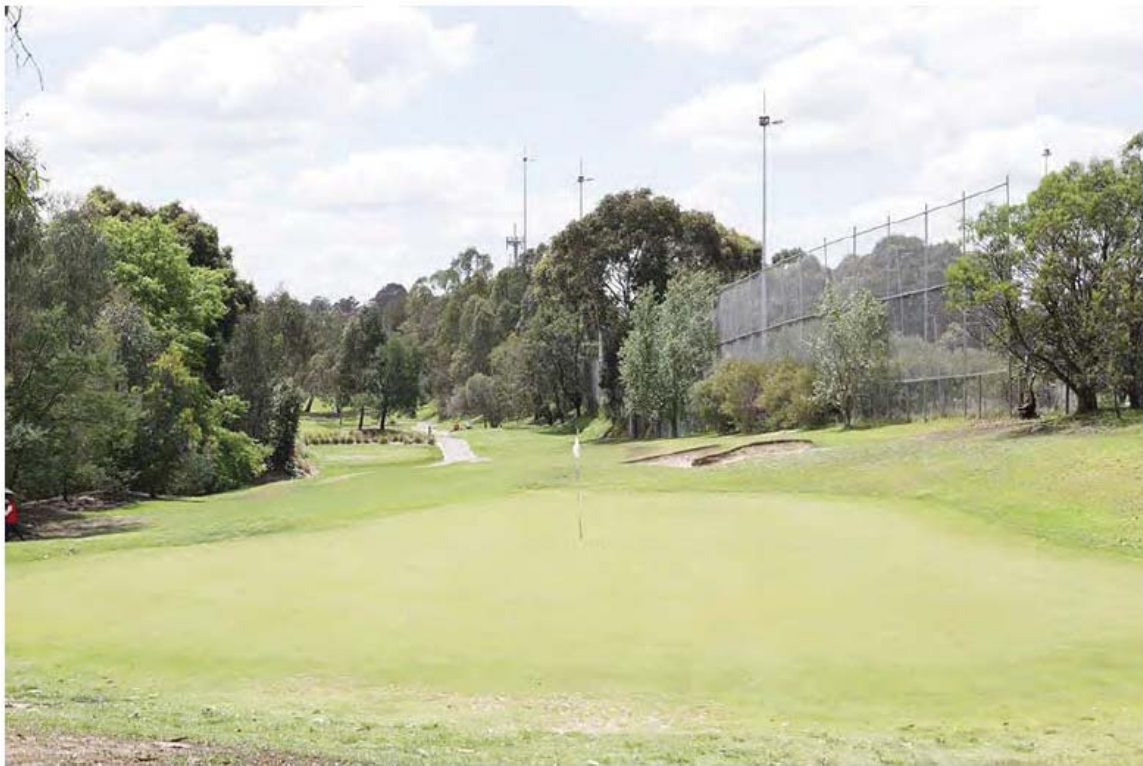
Figure 17: *Technical Report H - Photo 9-15 'VP39 - Existing view looking east'*

104. The 'existing view' shown in *Photo 9-15* within *Technical report H* does not represent an 80-degree horizontal field of view, and as such neither adequately represents the 'human eye' view extent from this location or the extent to which the view is likely to be impacted by the project.

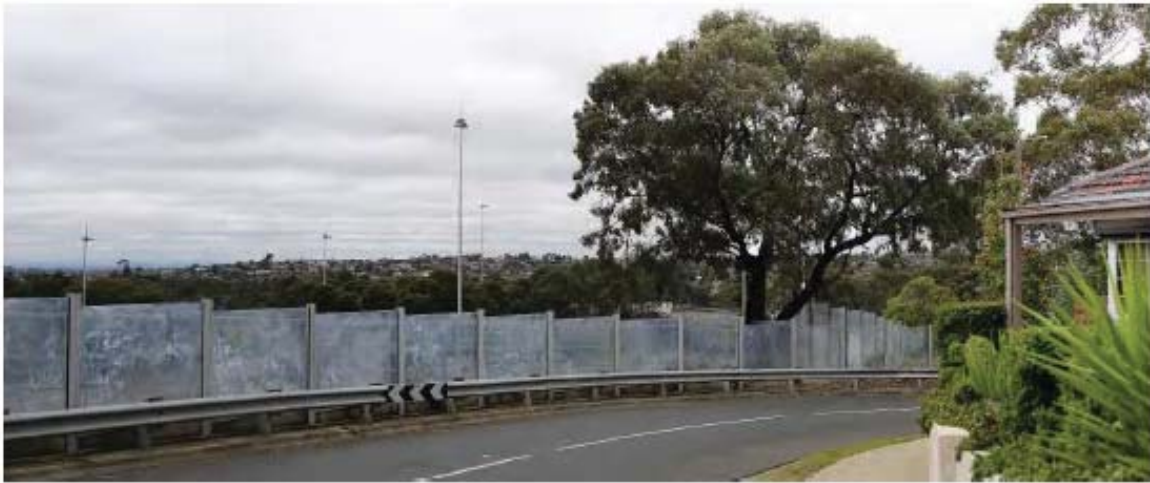
Figure 18: Technical Report H - Photo 9-16 'VP40 - Existing view looking north east'

111. The 'existing view' shown in *Photo 9-16* within *Technical report H* does not represent an 80-degree horizontal field of view, and has represented a horizontal field of view in the order of 65-degrees only. As such neither adequately represents the 'human eye' view extent from this location or the extent to which the view is likely to be impacted by the project.

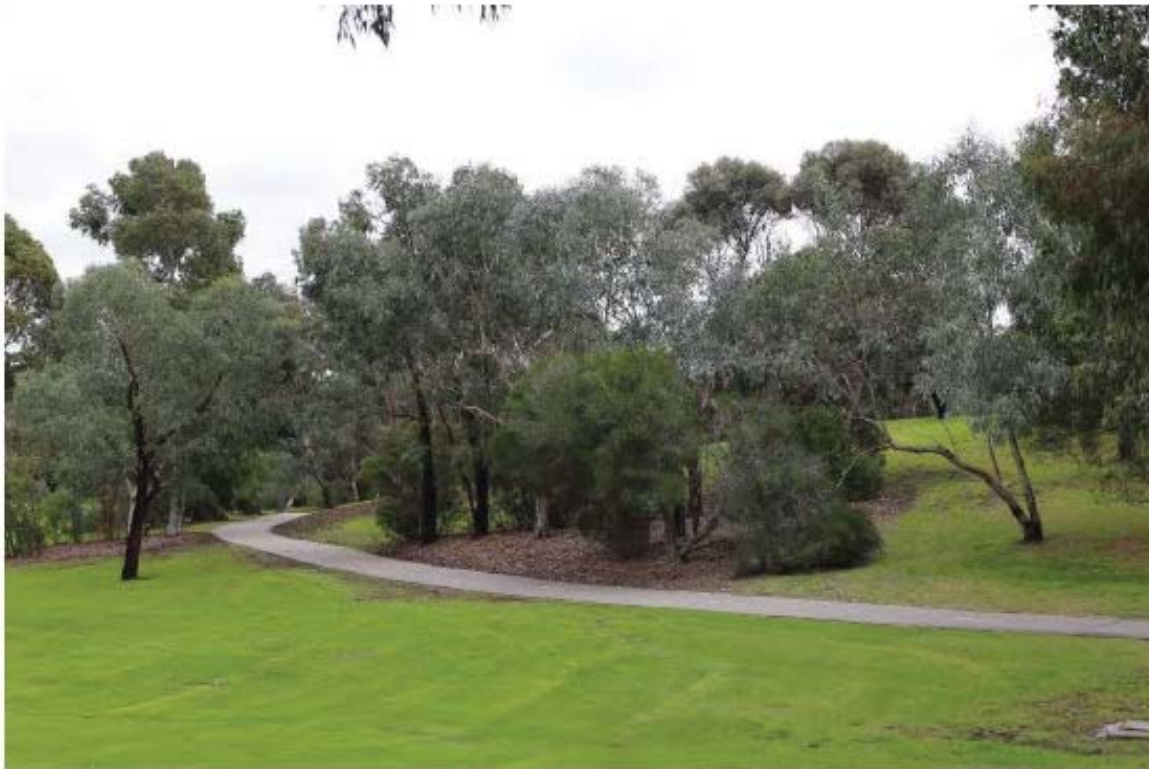
Figure 19: *Technical Report H - Photo 9-17 'VP41 - Existing view looking west'*

118. The assessment of visual impact as "Negligible" is questionable on the basis that existing vegetation would be removed and an existing noise wall replaced by a noise wall that is higher. The assessment of visual impact at year 0 is "negligible" however, the supporting cross section *Figure 9-17 VP41 – Landscape treatment looking west'* shows proposed buffer planting which appears to be relied upon to screen the proposed noise wall. In my opinion, the assessment rationale that existing vegetation would sufficiently screen the proposed noise wall is contradictory to the supporting information in the report. No photomontage is provided to support the assessment.

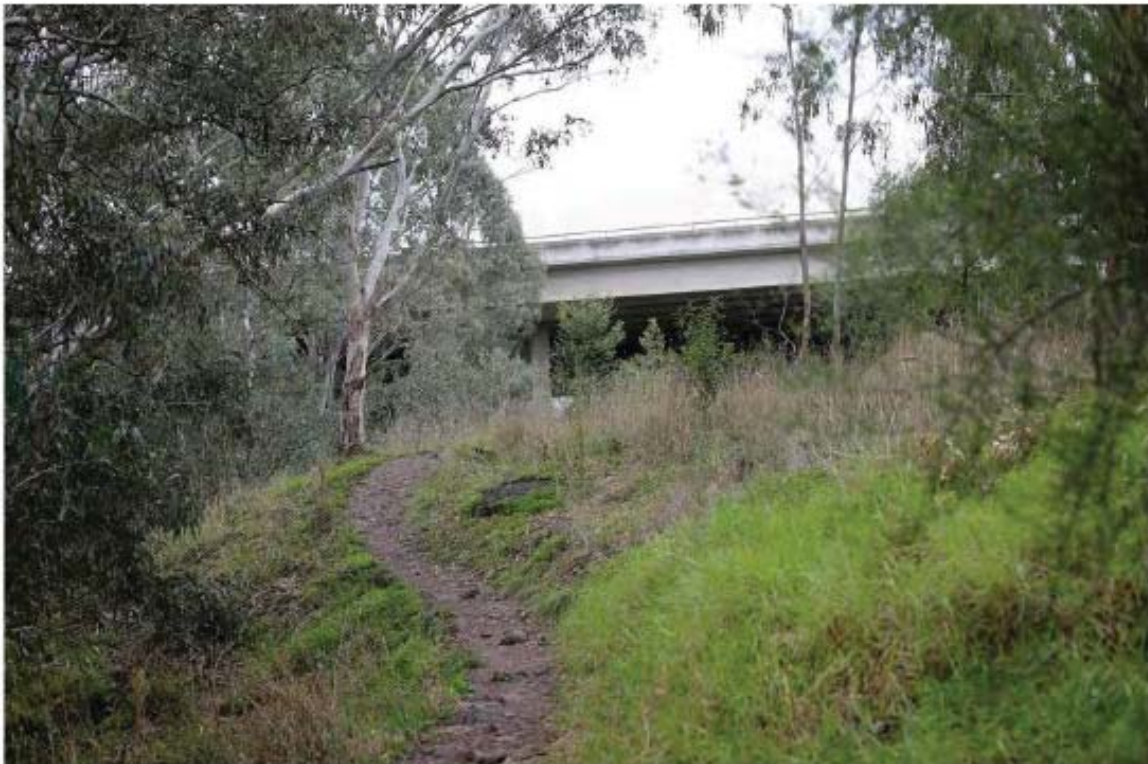
Figure 20: *Technical Report H - Photo 9-21 'VP46 - Existing view south'*

122. The 'existing view' shown in *Photo 9-21* within *Technical Report H* does not represent an 80-degree horizontal field of view, and as such neither adequately represents the 'human eye' view extent from this location or the extent to which that view is likely to be impacted by the project.

126. On the basis of the above findings, it is my opinion that the assessment of visual impact is misleading as it fails to adequately assess the impact on the main trail and assumptions regarding the proposed urban design treatments have not been clearly stated. Therefore, the assessment should not be relied upon as a means of understanding the visual impact expected in this location as a result of the project.

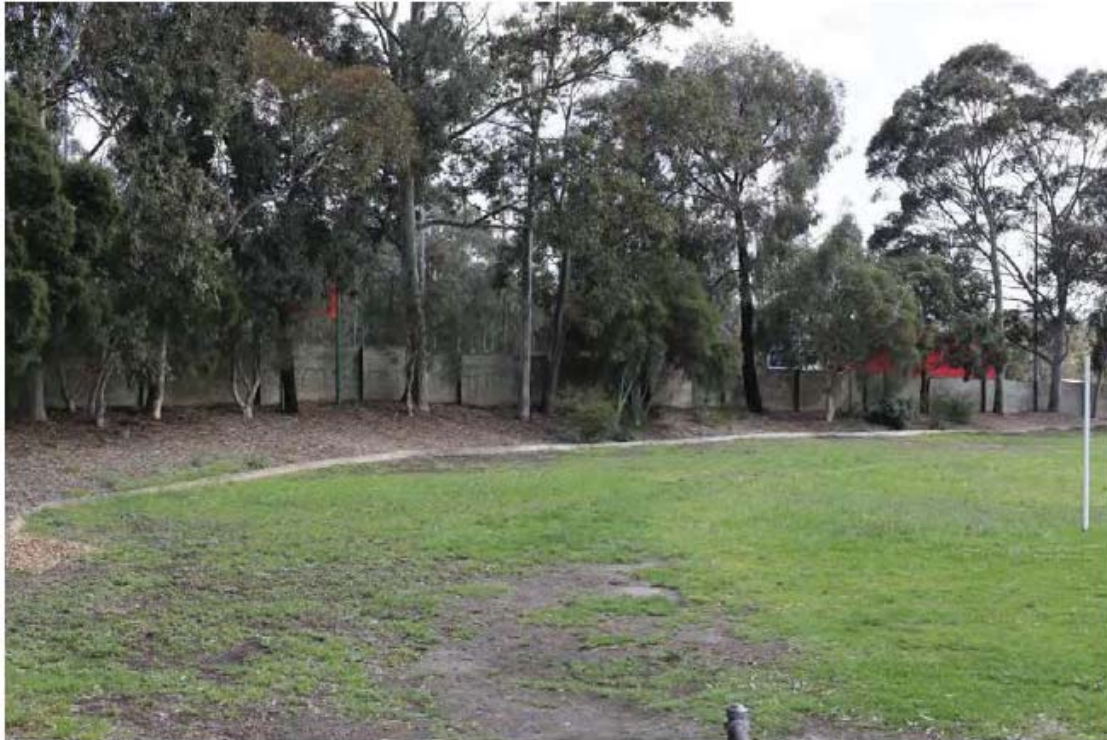
Figure 21: Technical Report H - Photo 9-22 'VP47 Existing view looking north'

128. The 'existing view' shown in *Photo 9-22* within *Technical Report H* does not represent an 80-degree horizontal field of view, and as such neither adequately represents the 'human eye' view extent from this location or the extent to which that view is likely to be impacted by the project.

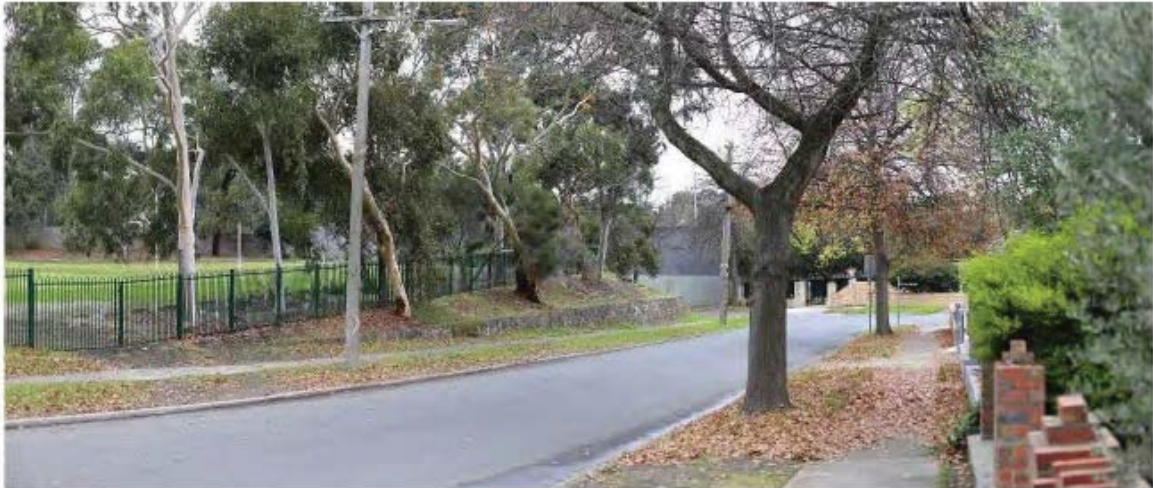
Figure 22: *Technical Report H - Photo 9-23 'VP48 - Existing view north-west'*

133. The 'existing view' shown in *Photo 9-23* within *Technical Report H* does not represent an 80-degree horizontal field of view, and as such neither adequately represents the 'human eye' view extent from this location or the extent to which that view is likely to be impacted by the project.

134. The assessment of Viewpoint 48 makes reference to the visual impact of the proposed noise wall on users, where the camera is located on a residential footpath looking towards the proposed structure. However, the report fails to consider the visual impact on the shared use path which is in closer proximity to the proposed structure and would likely experience higher foot and bicycle traffic than the selected viewpoint.

135. On the basis of the above, it is my opinion that the assessment of visual impact at Viewpoint 48 is misleading as it fails to represent the impact on the shared path and as such should not be relied upon as a means of understanding the extent of visual impact in this location as a result of the project.

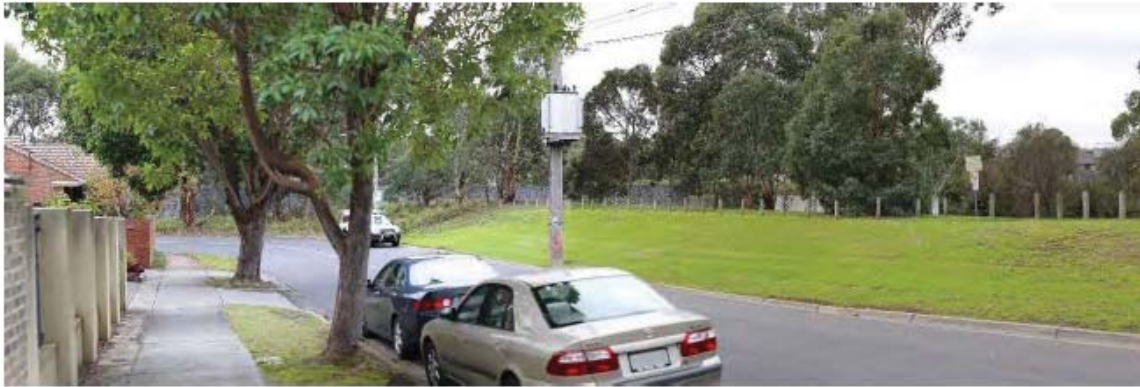
Figure 23: Technical Report H - Photo 9-24 'VP49 - Existing view looking north east'

138. The 'existing view' shown in *Photo 9-24* within *Technical Report H* does represent an 80-degree horizontal field of view, and adequately represents the 'human eye' view extent from this location. However, the camera position along the footpath is not representative of the full extent of visual impacts experienced in the broader landscape in and around Koonung Creek Reserve.

141. On the basis of the above, it is my opinion that the assessment of visual impact at Viewpoint 49 is misleading as it fails to represent the impact on the shared path and the assessment is unsubstantiated. As such, the assessment of visual impact for Viewpoint 49 should not be relied upon as a means of understanding the extent of visual impact in this location as a result of the project.

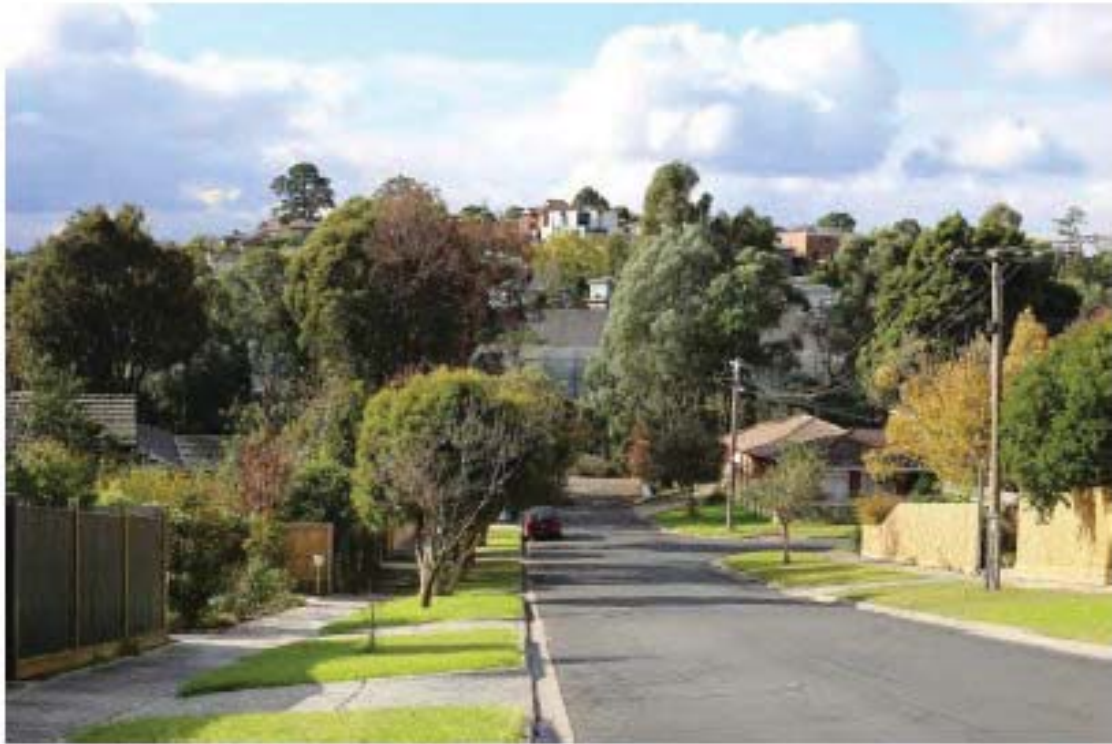
Figure 24: Technical Report H - Photo 9-31 'VP56 - Existing view looking north-east'

143. The 'existing view' shown in *Photo 9-31* within *Technical Report H* does not represent an 80-degree horizontal field of view, and as such neither adequately represents the 'human eye' view extent from this location or the extent to which that view is likely to be impacted by the project.
