North East Link Project

EES Inquiry and Advisory Committee (IAC)

Statement of landscape and visual amenity evidence

Stephen Schutt of Hansen Partnership Pty Ltd.

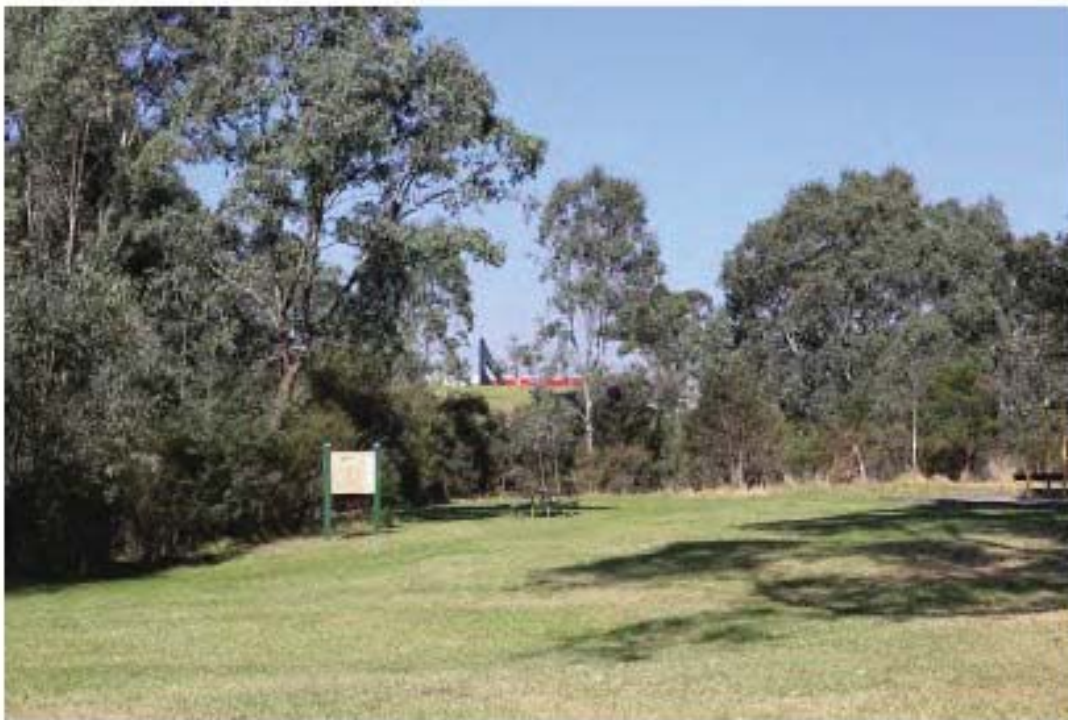
Figure 25: *Technical Report H - Photo 9-1 'VP25 - Existing view looking south-east'*

149. The 'existing view' shown in *Photo 9-1* within *Technical Report H* does not represent an 80-degree horizontal field of view, and as such neither adequately represents the 'human eye' view extent from this location or the extent to which that view is likely to be impacted by the project.

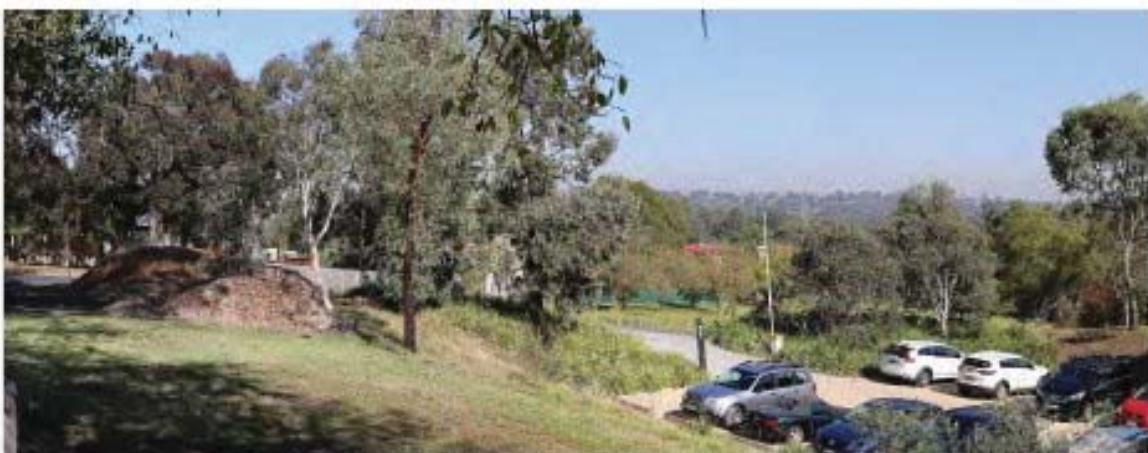
Figure 26: *Technical Report H - Photo 9-2 VP26 - Existing view south-west'*

155. The 'existing view' shown in *Photo 9-2* within *Technical Report H* does not represent an 80-degree horizontal field of view, and as such neither adequately represents the 'human eye' view extent from this location or the extent to which that view is likely to be impacted by the project.

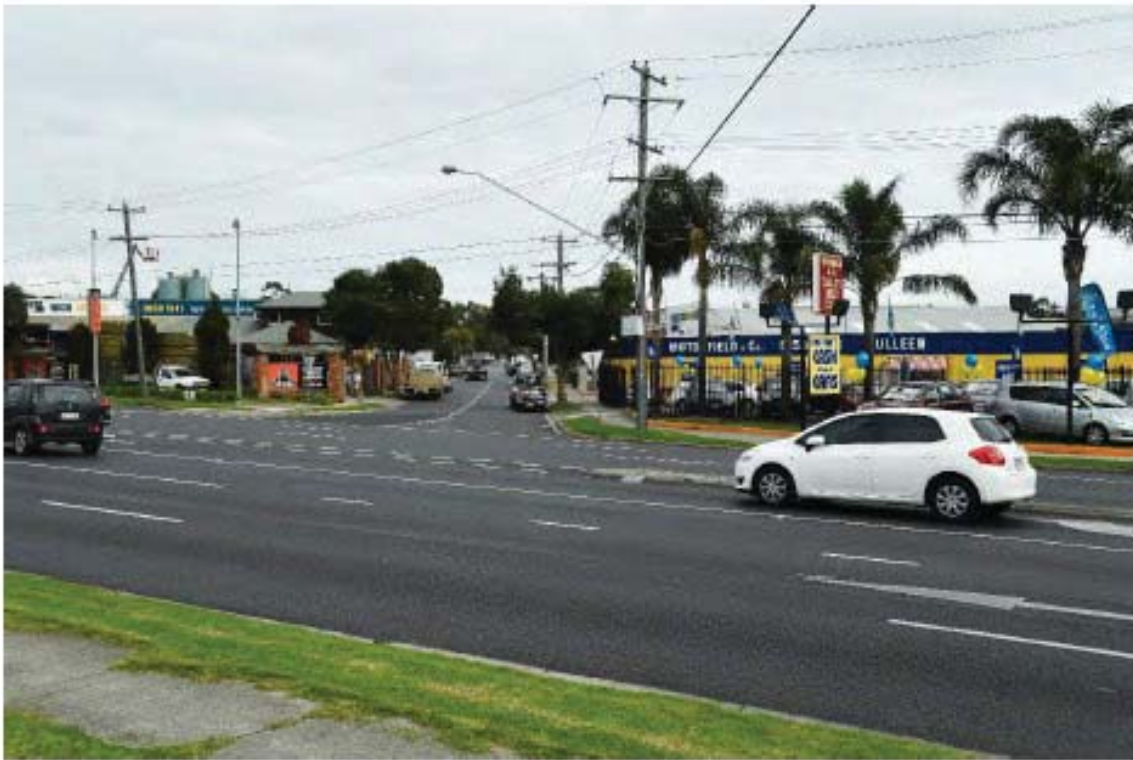
Figure 27: Technical Report H - Photo 9-4 'VP28 - Existing view looking south-west'

159. The rationale for the selection of this viewpoint is not stated. It is unclear whether this viewpoint is intended to be representative of broader impacts, and if so what the likely extent of those broader impacts is.
160. The ‘existing view’ shown in *Photo 9-4* within *Technical Report H* does not represent an 80-degree horizontal field of view, and as such neither adequately represents the ‘human eye’ view extent from this location or the extent to which that view is likely to be impacted by the project.

161. No photomontage is provided, and instead the report includes a cross section *Figure 9-11 'VP28 – Landscape treatment section view south'*. The cross section does show a proposed flood-wall, however it fails to represent the full extent of the proposed visual impact at Viewpoint 28. The assessment of “Negligible” impact at this viewpoint, therefore is in my opinion questionable.

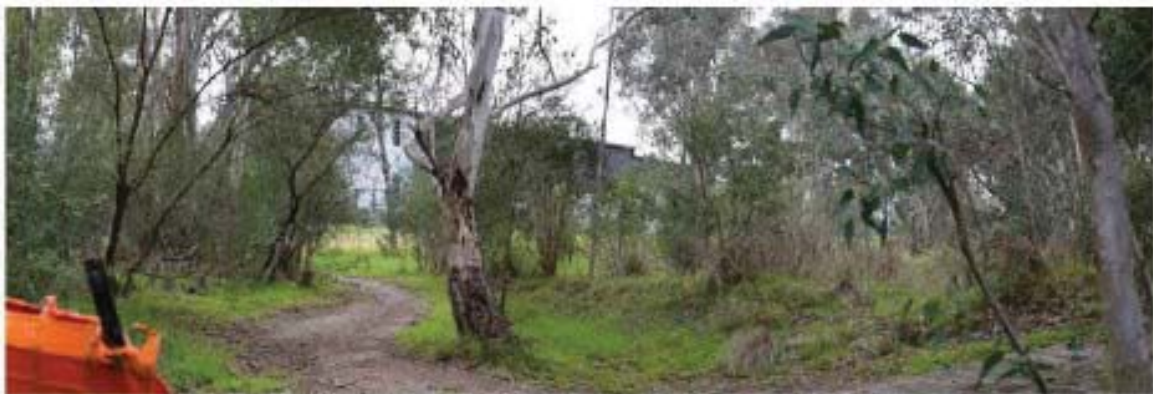
Figure 28: *Technical Report H - Photo 9-5 'VP29 - Existing view north-east'*

166. The ‘existing view’ shown in *Photo 9-5* within *Technical Report H* does not represent an 80-degree horizontal field of view, and as such neither adequately represents the ‘human eye’ view extent from this location or the extent to which that view is likely to be impacted by the project.

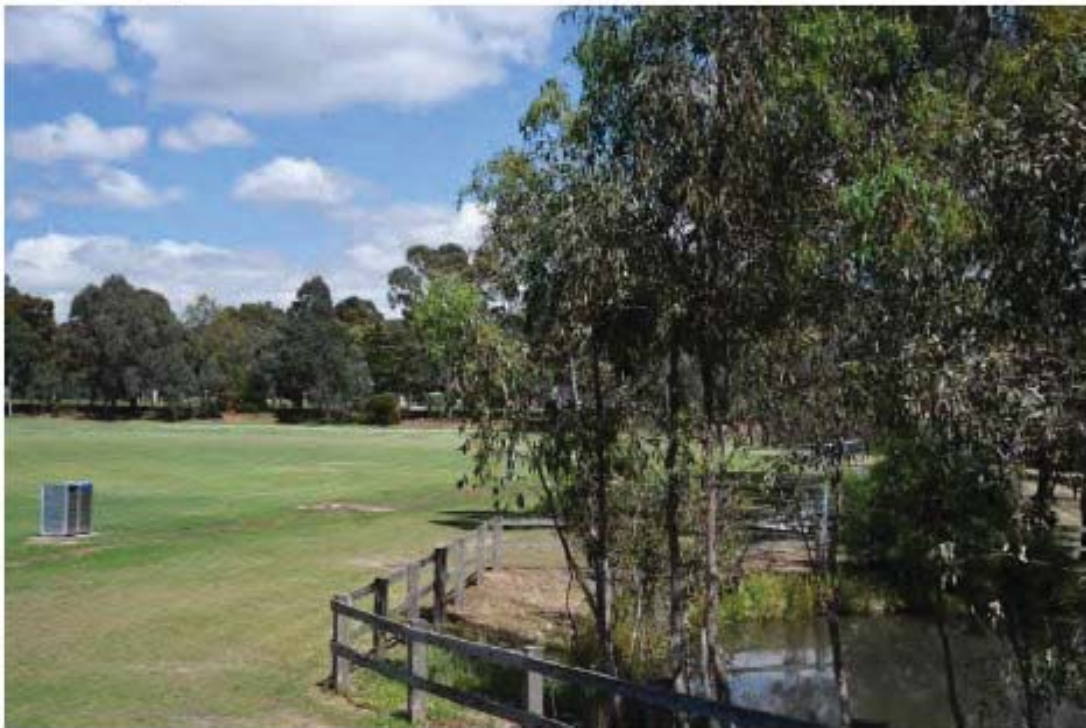
Figure 29: *Technical Report H - Photo 9-8 'VP32 - Existing view looking west'*

171. The 'existing view' shown in *Photo 9-8* within *Technical Report H* does not represent an 80-degree horizontal field of view, and as such neither adequately represents the 'human eye' view extent from this location or the extent to which that view is likely to be impacted by the project.

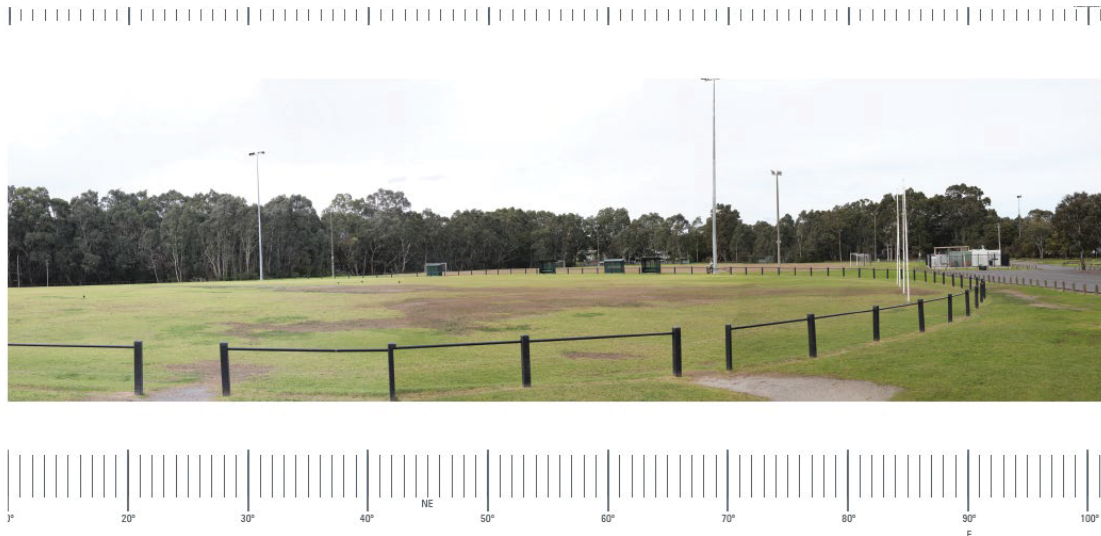
Figure 30: Appendix A: Photomontage 9 – from Bulleen Park Oval viewing pavilion facing north-east towards the proposed ventilation outlet and potential construction compound.

177. The visual impact on **Bulleen Park, Bulleen** due to a proposed 40m high ventilation structure has been assessed at Viewpoint 35 in the Technical report. However, the selected location 670m from the structure is questionable on the basis that there is a closer viewing pavilion and carpark within Bulleen Park which, on the basis of closer proximity, would be more sensitive to the proposed change. The existing view from the Bulleen Park Pavilion is shown in *Photomontage 9* in *Appendix A* (refer Figure 30 below).

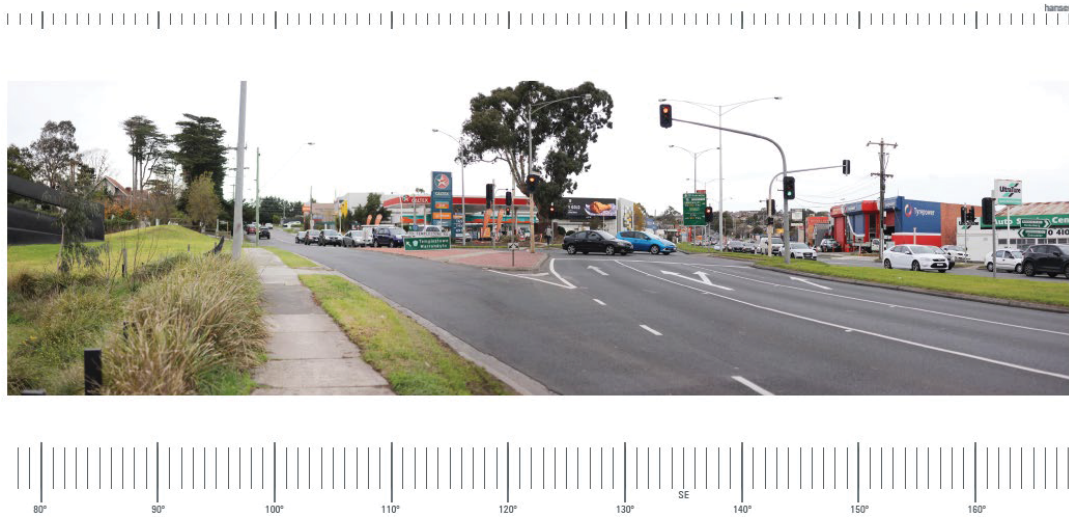
Figure 31: Appendix A: Photomontage 13 – from Bridge Street & Manningham Road intersection (Bulleen), facing south-east towards proposed raised pedestrian overpass and new road alignment

179. It is my opinion that assessment of the above elements is achievable with correct viewpoint selection and photomontage technique, at the camera position shown in Figure 31 below (refer to Appendix A – Photomontage 13).

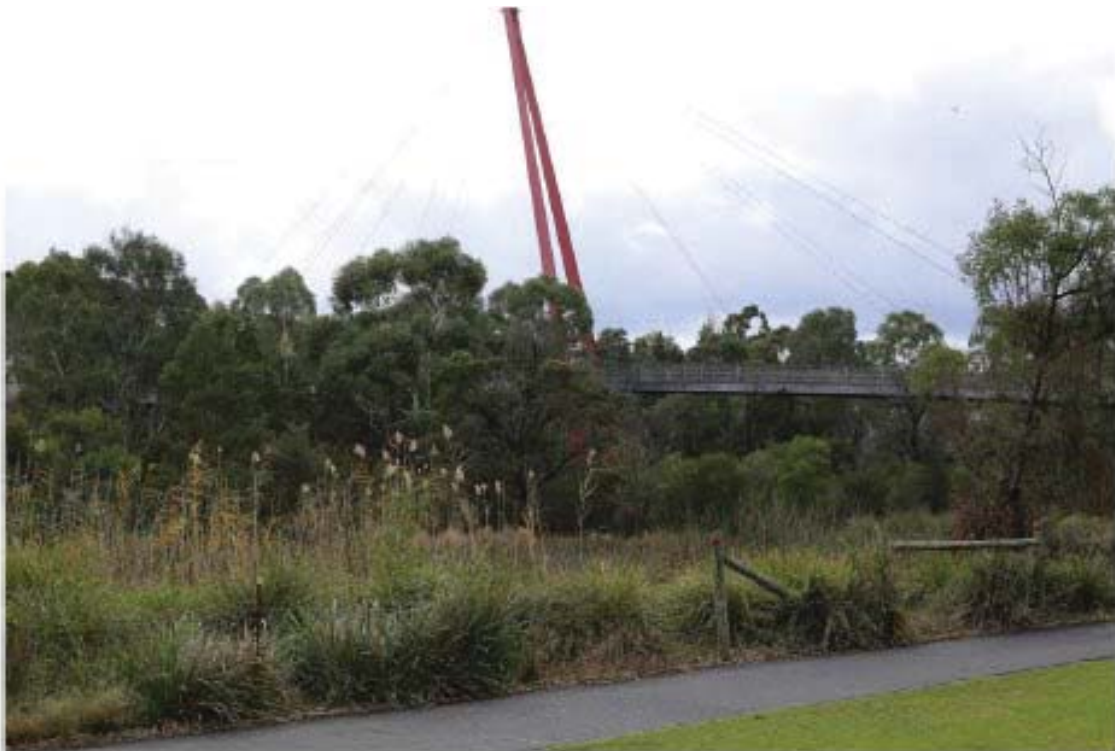
Figure 32: Technical Report H - Photo 9-33 'VP58 - Existing view north-east'

182. The 'existing view' shown in *Photo 9-33* within *Technical Report H* does not represent an 80-degree horizontal field of view, and as such neither adequately represents the 'human eye' extent of view from this location or the extent to which that view is likely to be impacted by the project.

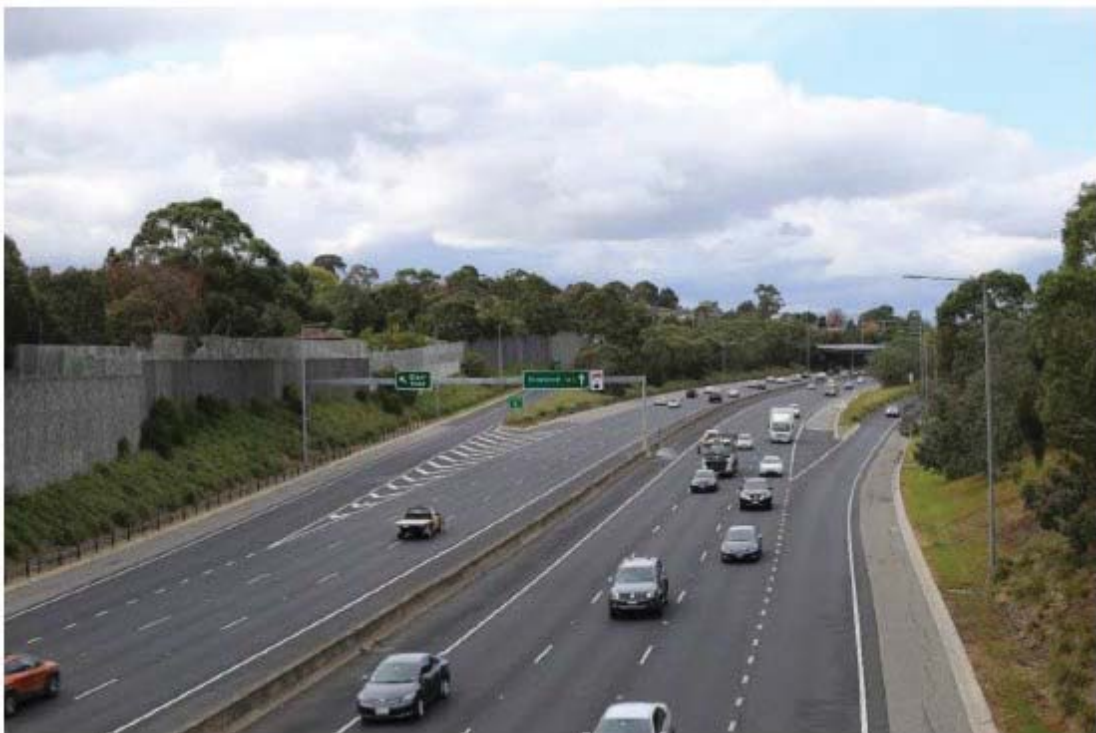
Figure 33 Technical Report H - Photo 9-34 'VP59 - Existing view looking east'

186. The ‘existing view’ shown in *Photo 9-34* within *Technical Report H* does not represent an 80-degree horizontal field of view, and as such neither adequately represents the ‘human eye’ extent of view from this location or the extent to which that view is likely to be impacted by the project.

187. The assessment of visual impact as “low” at Year 0 and Year 10 at Viewpoint 59 is questionable given the extent of proposed change to the road landscape, with particular regard to the loss of vegetation as a result of the proposed changes. No photomontage has been provided to support the assessment.

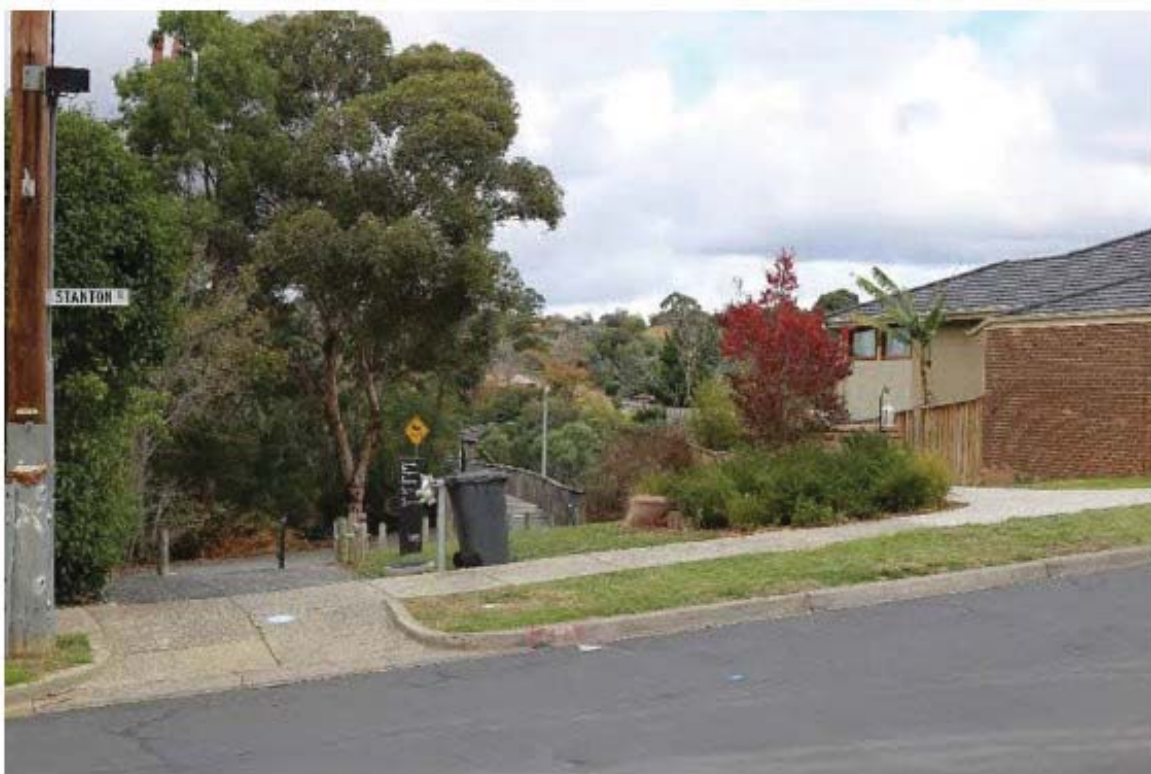
Figure 34: *Technical Report H - Photo 9-35 'VP60 - Existing view looking south'*

190. The ‘existing view’ shown in *Photo 9-35* within *Technical Report H* does not represent an 80-degree horizontal field of view, and as such neither adequately represents the ‘human eye’ extent of view from this location or the extent to which that view is likely to be impacted by the project.

191. It is my opinion that the assessment of visual impact as “negligible” at Year 0 and Year 10 at Viewpoint 60 is unsubstantiated and misleading on the basis that the rationale conflicts with the description of proposed change:

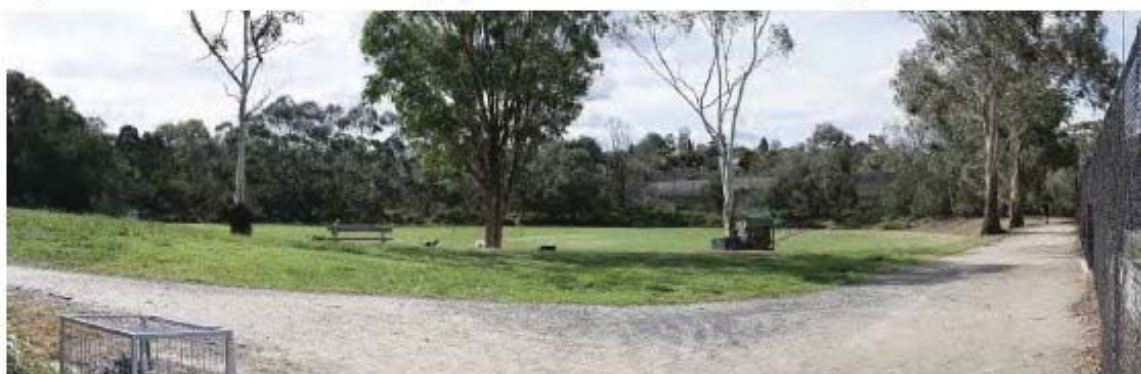
Figure 35: Technical Report H: Photo 9-37 'VP62 - Existing view looking north-west'

195. The assessment makes references to the visual impact on the viewpoint location, but fails to consider the visual impact on the Koonung Creek Trail, which will likely experience higher foot and bicycle traffic than the selected viewpoint shown in *Photo 9-37 VP62 – existing view looking north-west*.

196. On the basis of the above, it is my opinion that the assessment of visual impact at Viewpoint 2 is misleading as it fails to represent the impact on the shared use path and as such should not be relied upon as a means of understanding the extent of visual impact expected in this location as a result of the project.

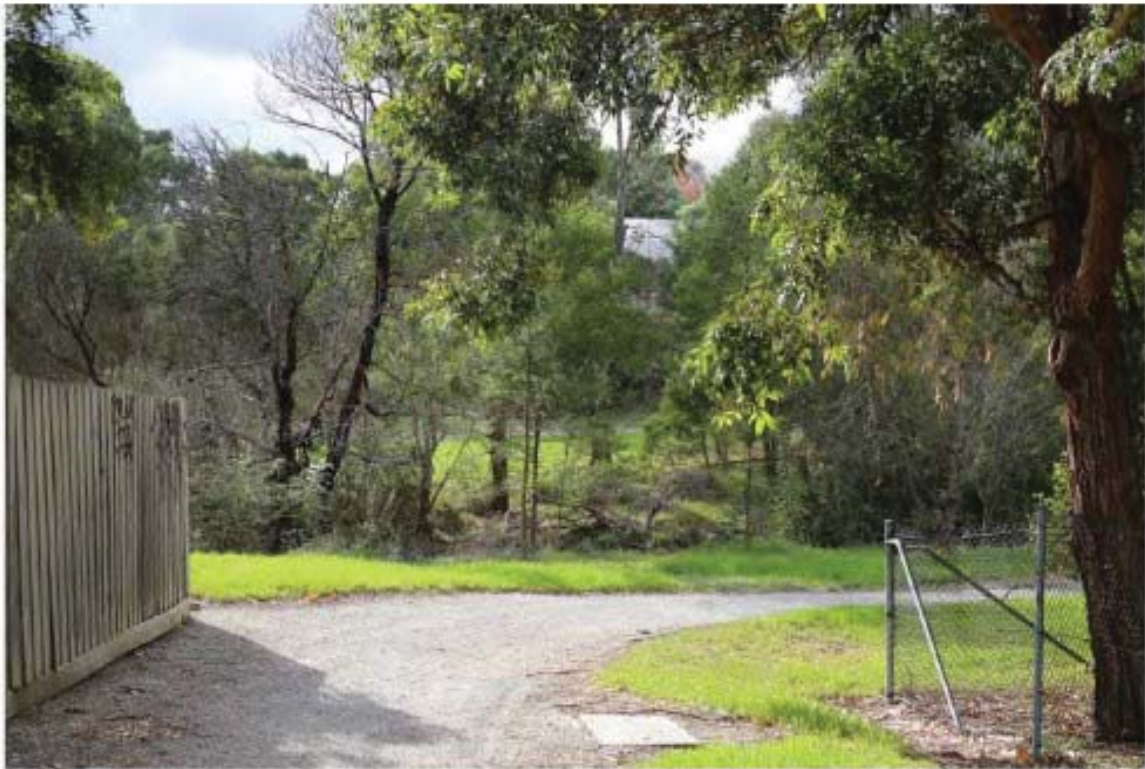
Figure 36: *Technical Report H - Photo 9-38 'VP63 - Existing view looking north'*

198. The 'existing view' shown in *Photo 9-38* within *Technical Report H* does not represent an 80-degree horizontal field of view, and as such neither adequately represents the 'human eye' extent of view from this location or the extent to which that view is likely to be impacted by the project.

199. It is not clear how the value of this landscape has influenced the assessment of visual impacts as "low" at Year 10 for Viewpoint 63. The location of the viewpoint is questionable given it does not appear to best represent the creek environs.

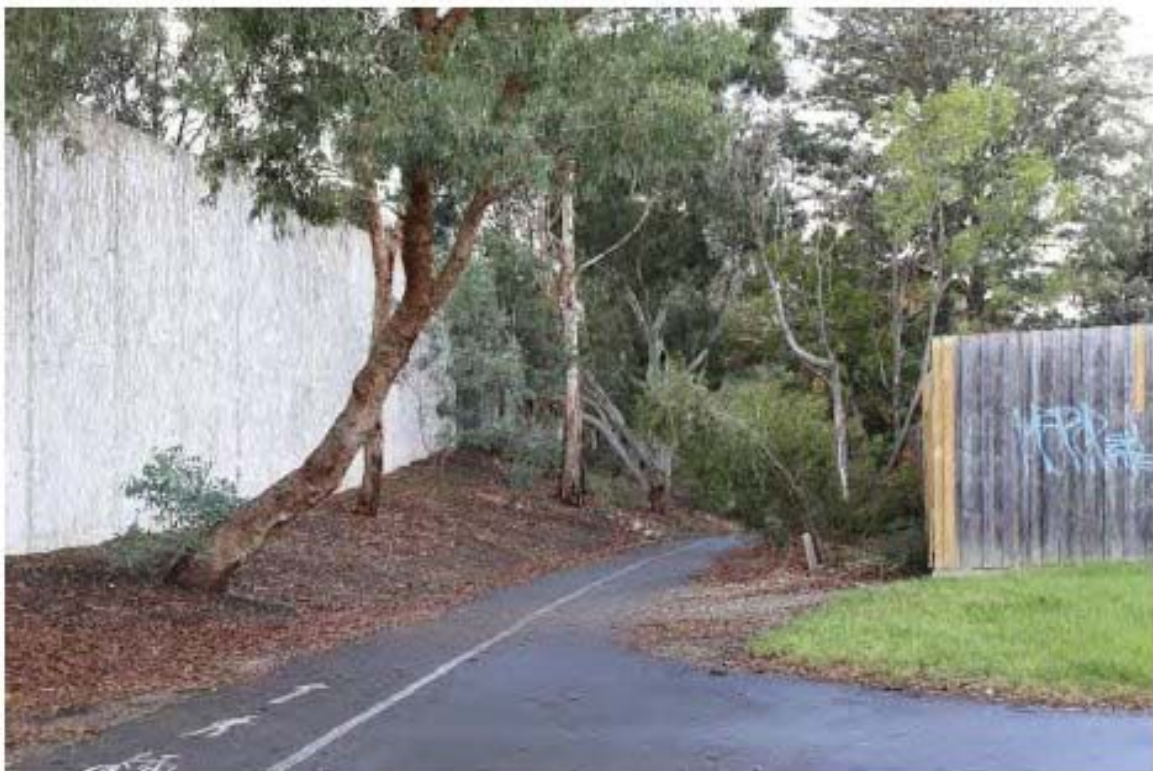
Figure 37: *Technical Report H - Photo 9-40 'VP65 - Existing view looking east'*

204. The 'existing view' shown in *Photo 9-40* within *Technical Report H* does not represent an 80-degree horizontal field of view, and as such neither adequately represents the 'human eye' extent of view from this location or the extent to which that view is likely to be impacted by the project.

205. The assessment of visual impact as "medium" at Viewpoint 65 is questionable given the proposed changes. No photomontage has been produced to substantiate the assessment, and the cross section provided is not an

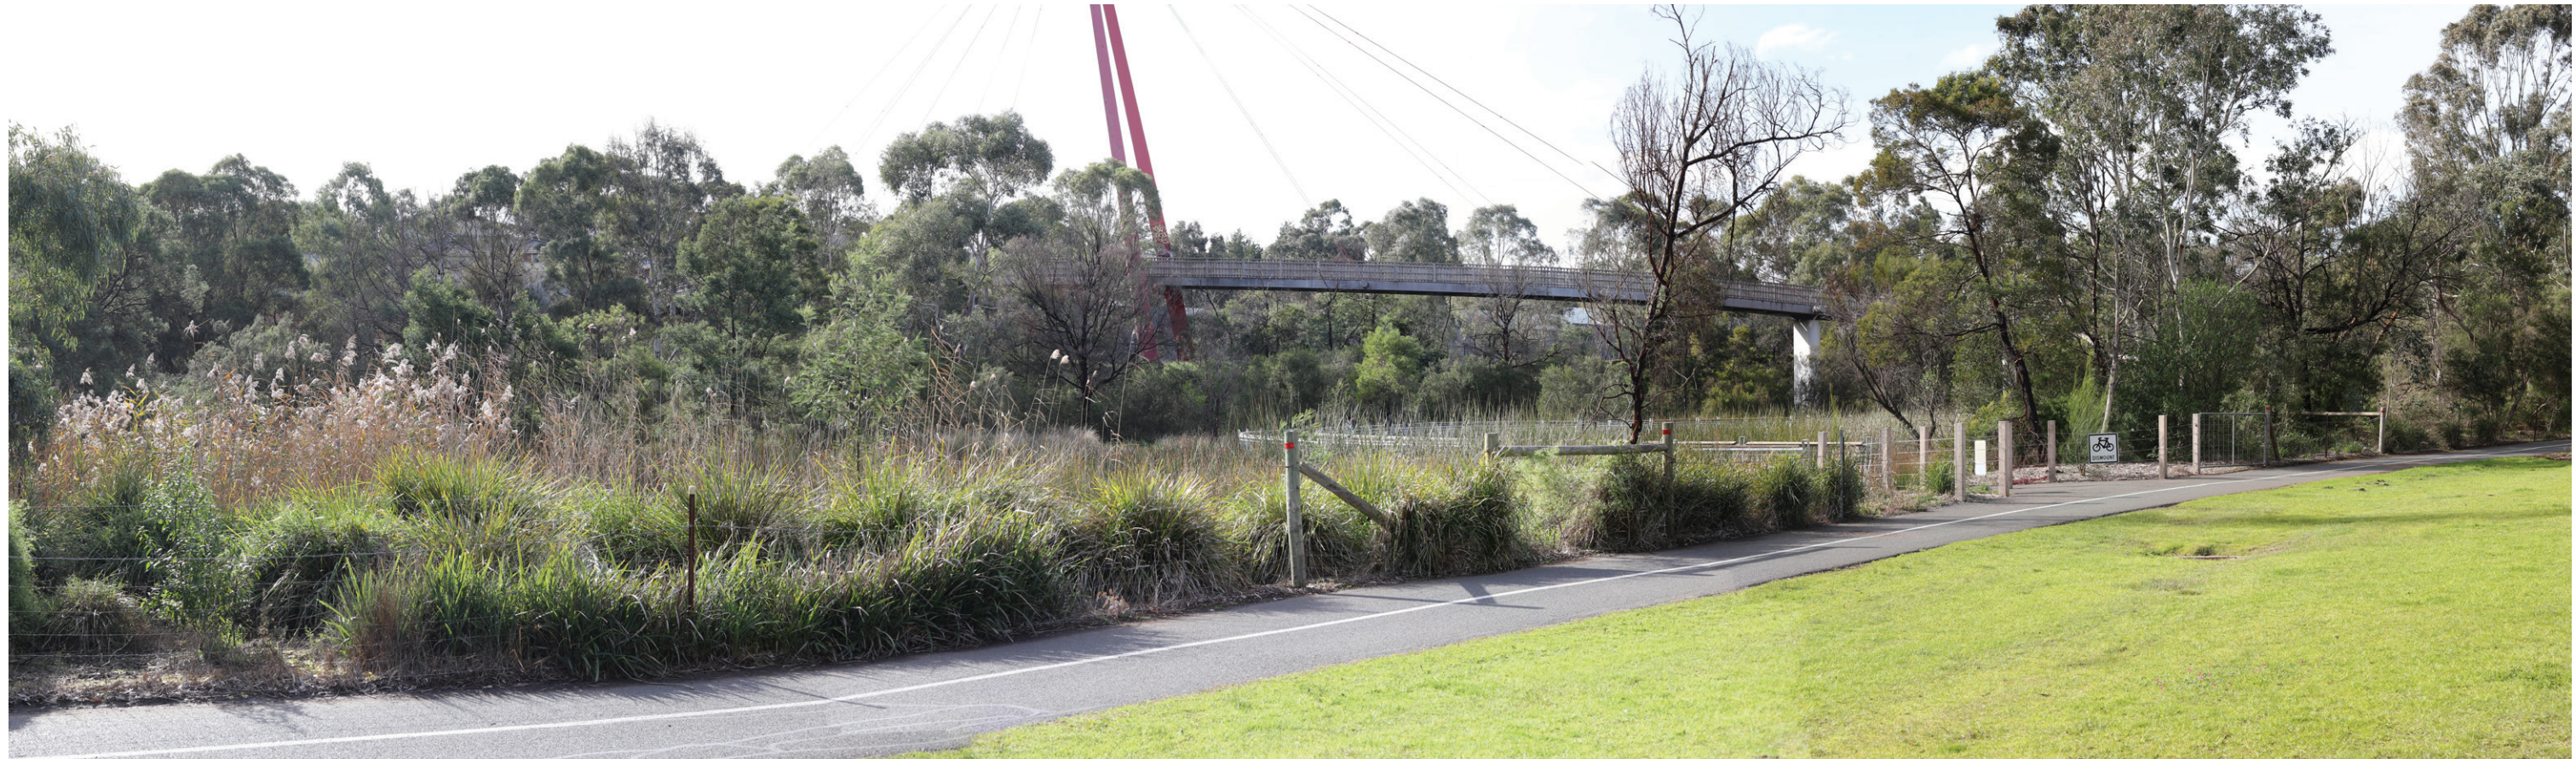
View location 2 - from Koonung Creek Wetlands Elgar Park (Mont Albert North), facing northeast towards proposed bridge and noisewall

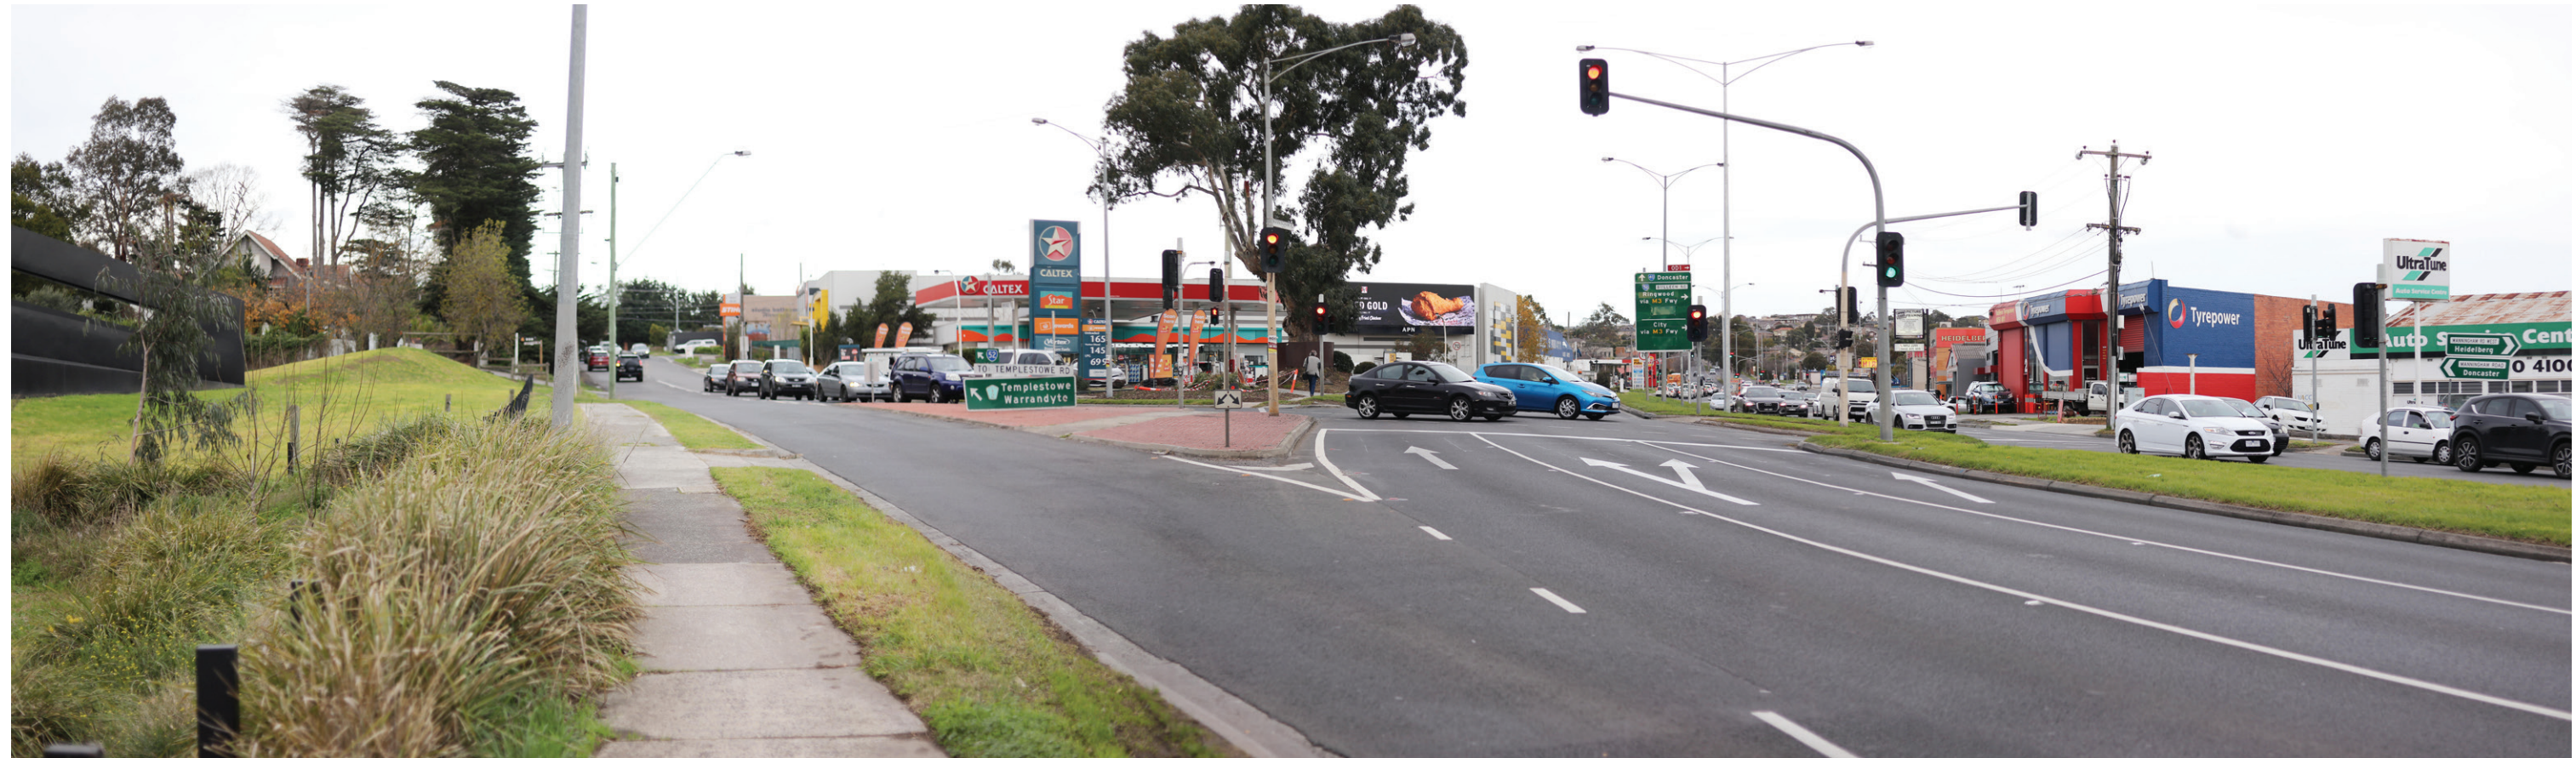
View location 13 - from Bridge Street & Manningham Road intersection (Bulleen), facing southeast towards proposed raised pedestrian overpass and new road alignment

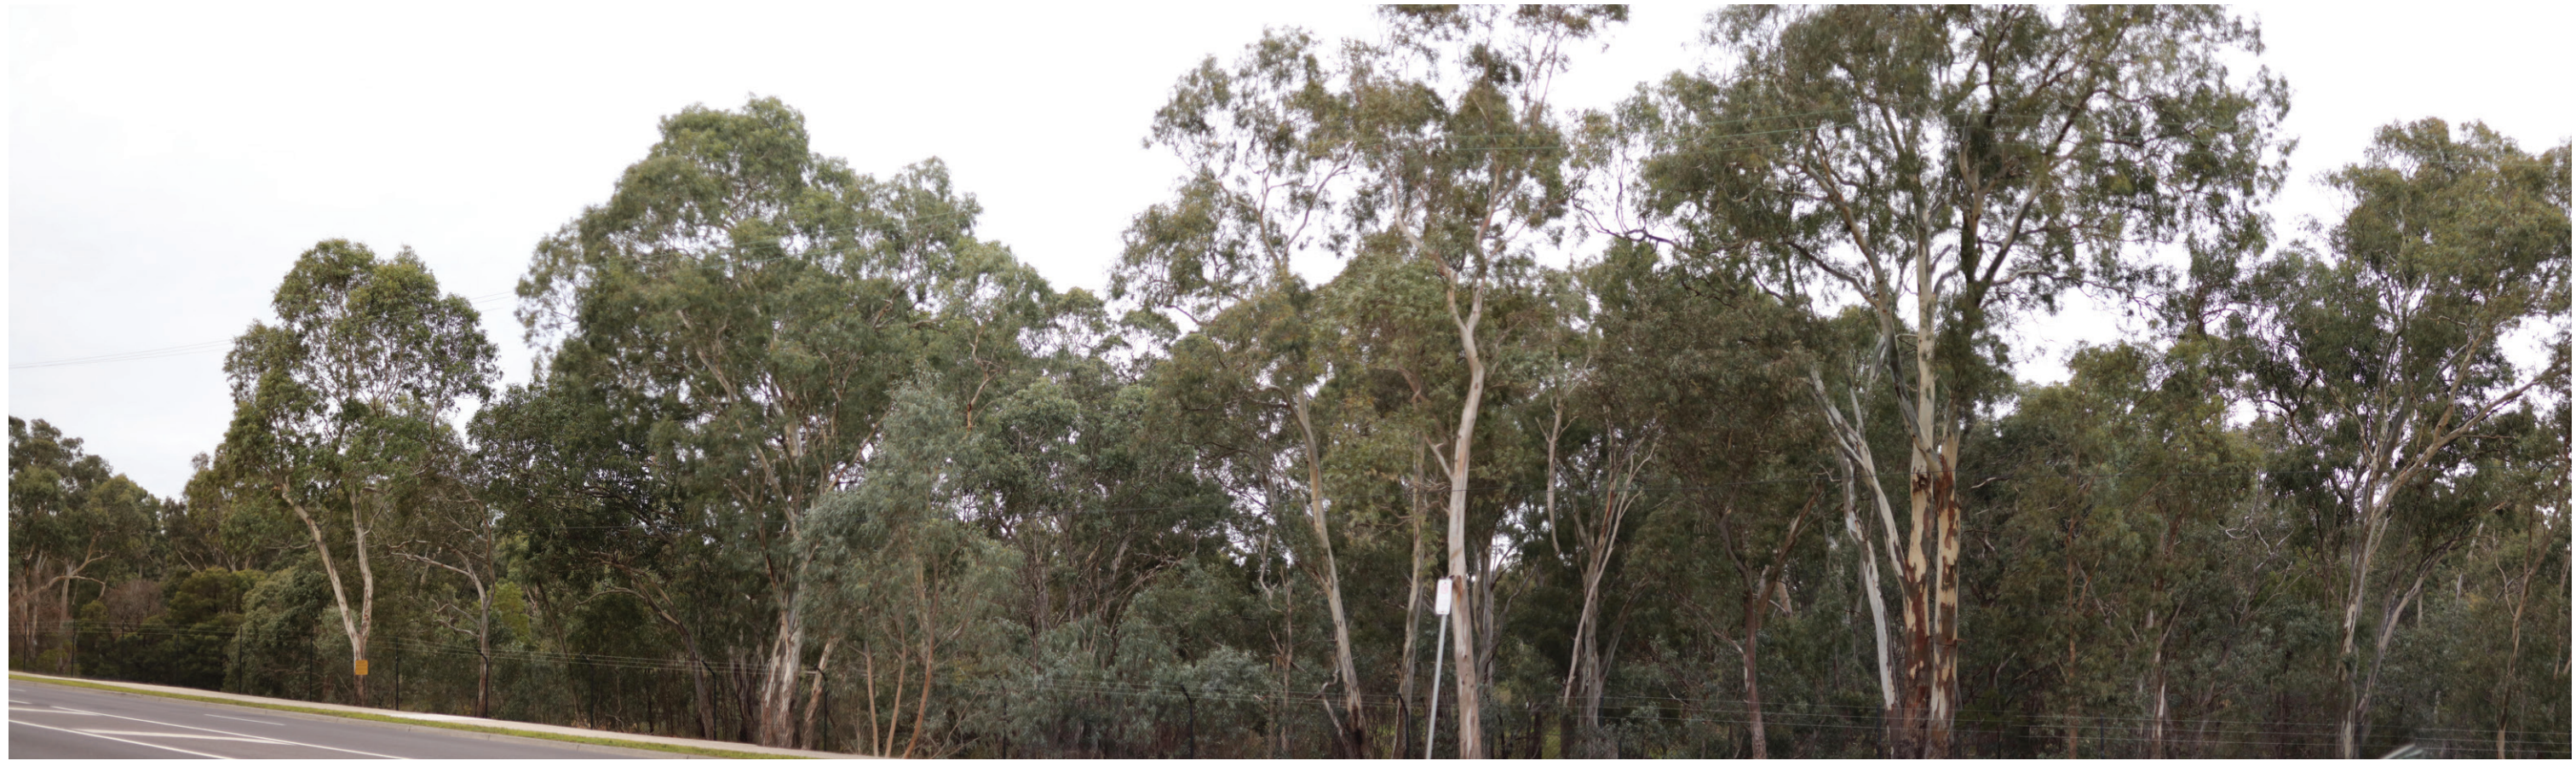
View location 15 - from corner Sydney St and Greensborough R (Macleod), facing east towards proposed Ventilation outlet building
