Domestic Wastewater Management Plan December 2019

1. Introduction

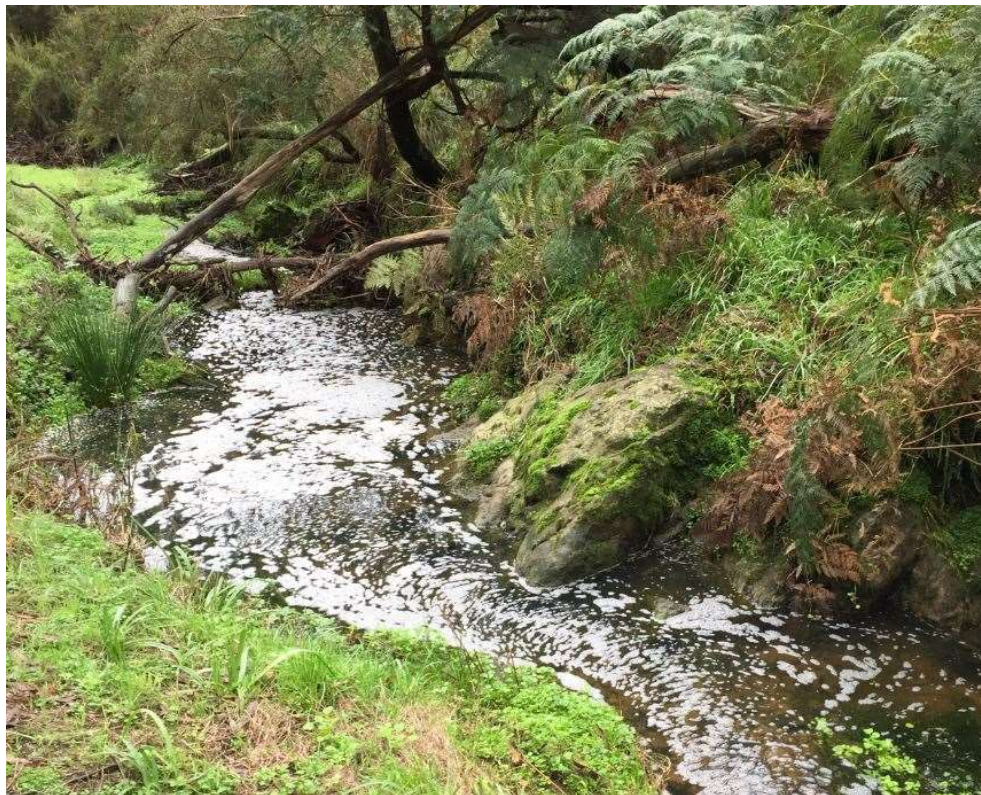
Figure 1: Soapy discharge entering Andersons Creek (May 2018)

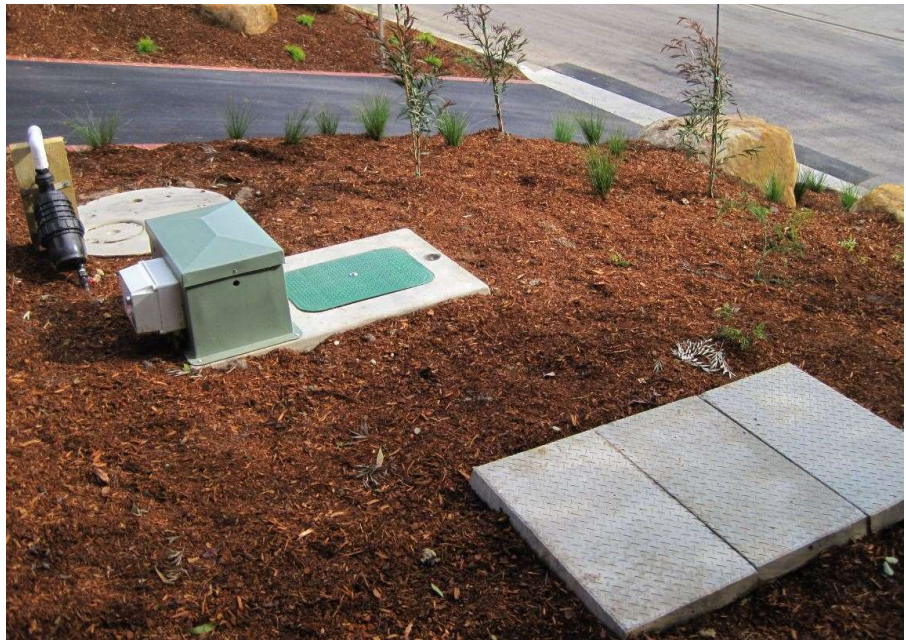
Figure 2: Treatment Plant with sub-surface irrigation

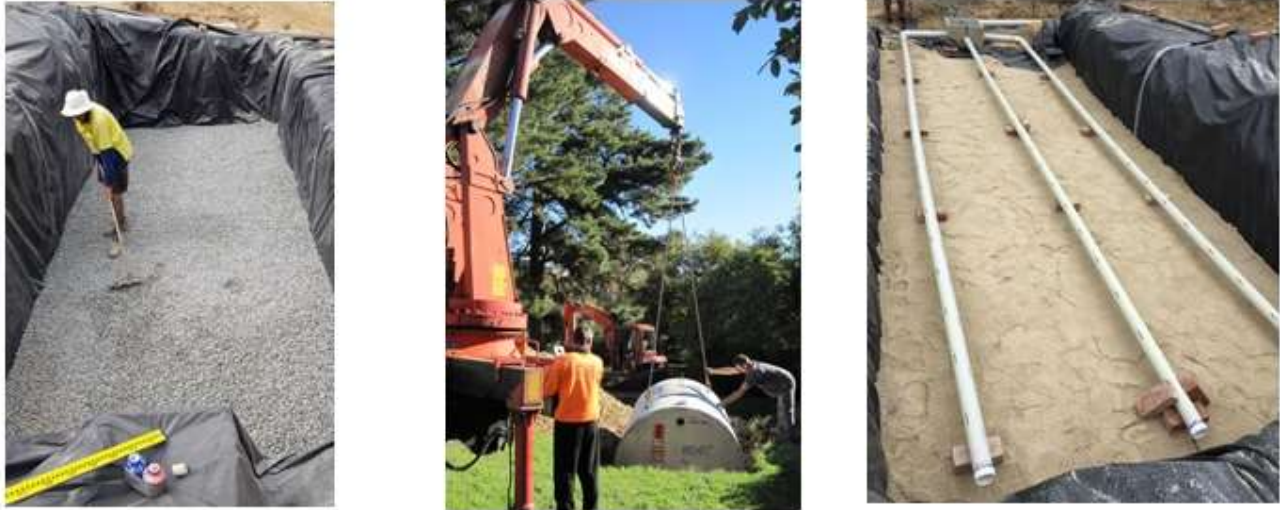
Figure 3: Septic system components in various stage of construction/installation

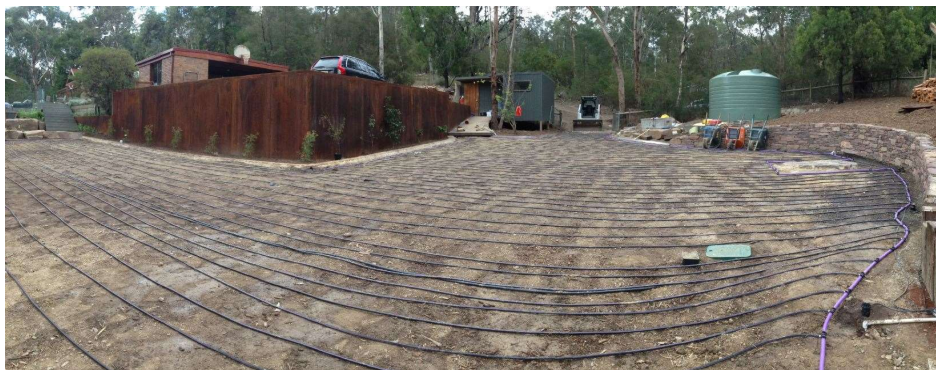
Figure 4: Lay-down of sub-surface irrigation

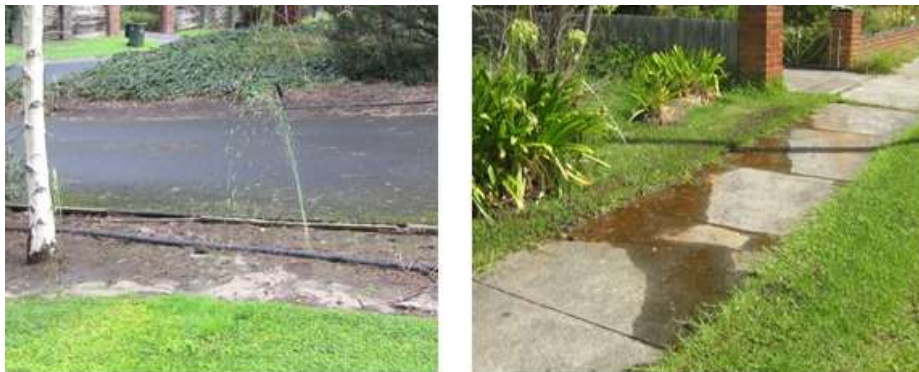
Figure 6: Burst dripper line and septic effluent flowing over footpath

- Sand filter blockages from tree roots (general maintenance required)
- Treatment plants not being serviced as no service contract in place
- Properties failing to desludge the septic tank every 3 years
- Redirected / bypassed irrigation systems offsite.
- Flush valves and inline cartridge filters being tampered with.

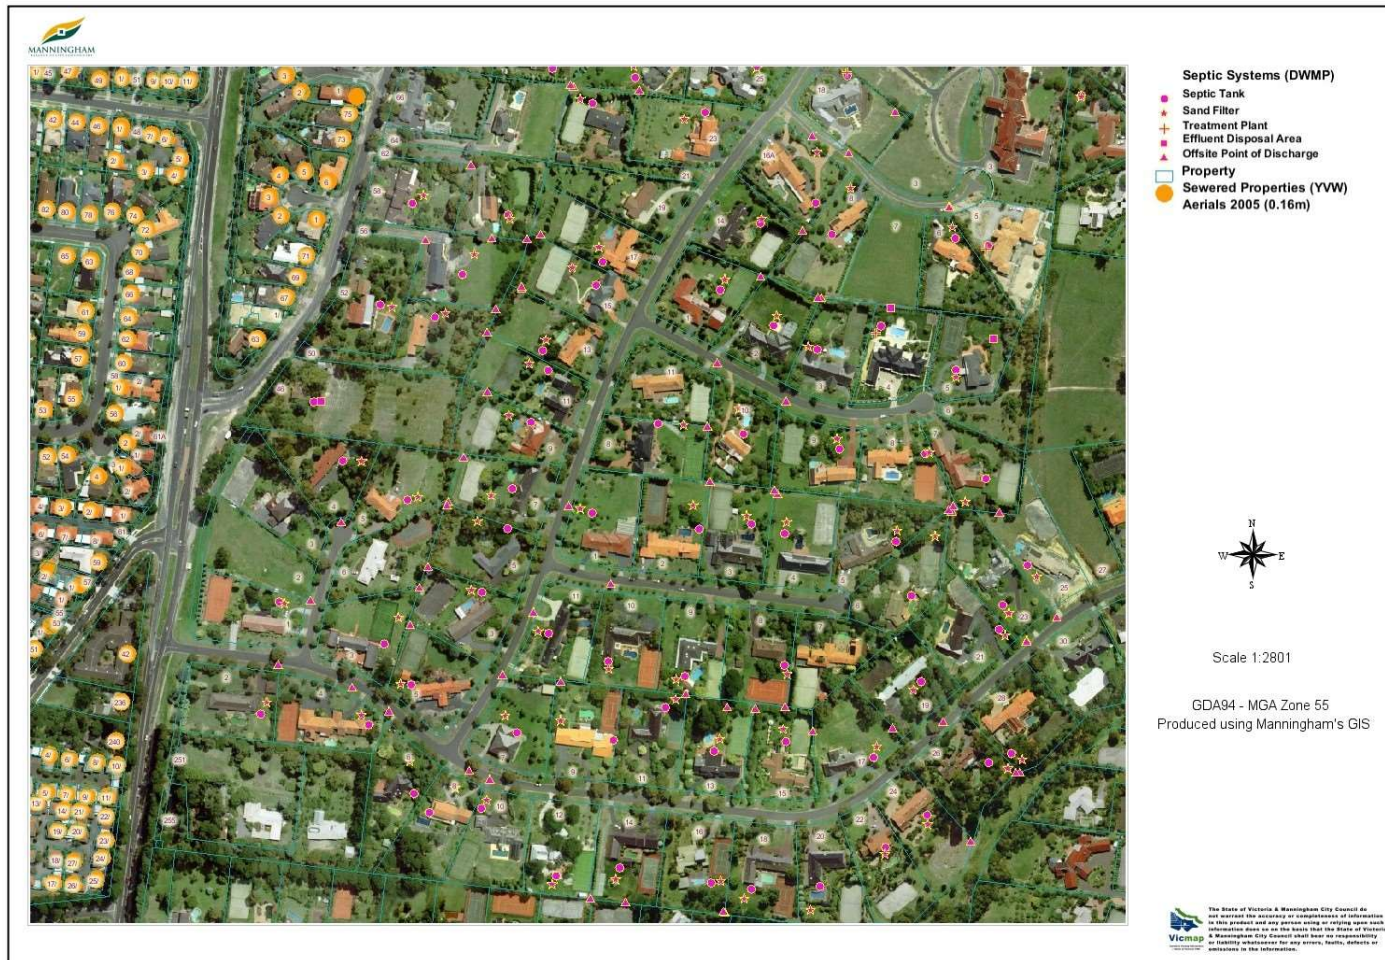
The image below shows Council's GIS overlay of septic systems in use. GPS is used to capture the exact location of system components (indicated by various pink symbols). The orange circles represent properties connected to sewer.

Figure 10: GIS overlay of septic system components in use (Donvale RA0041A)

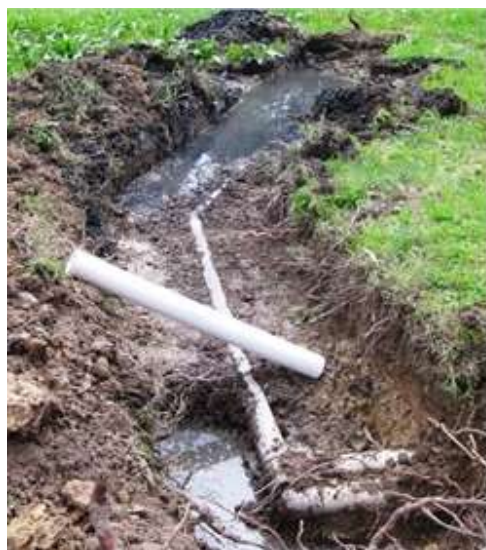
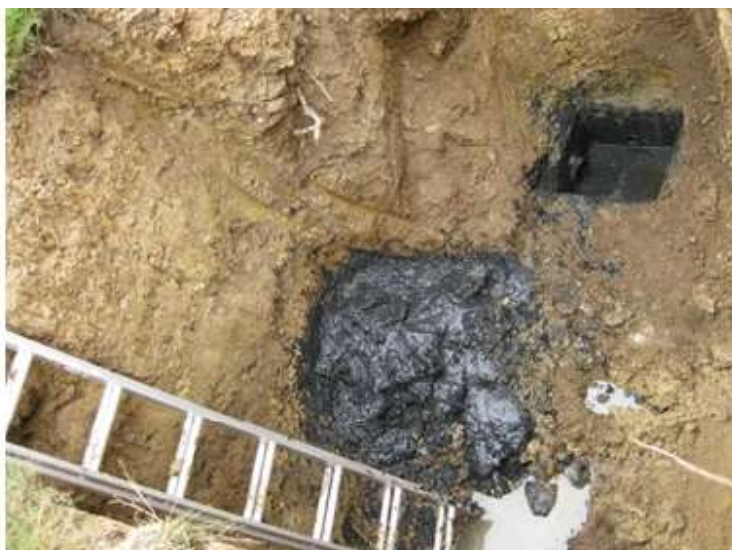
Figure 11: Flooded irrigation field and a deeply buried distribution pit (legacy system)

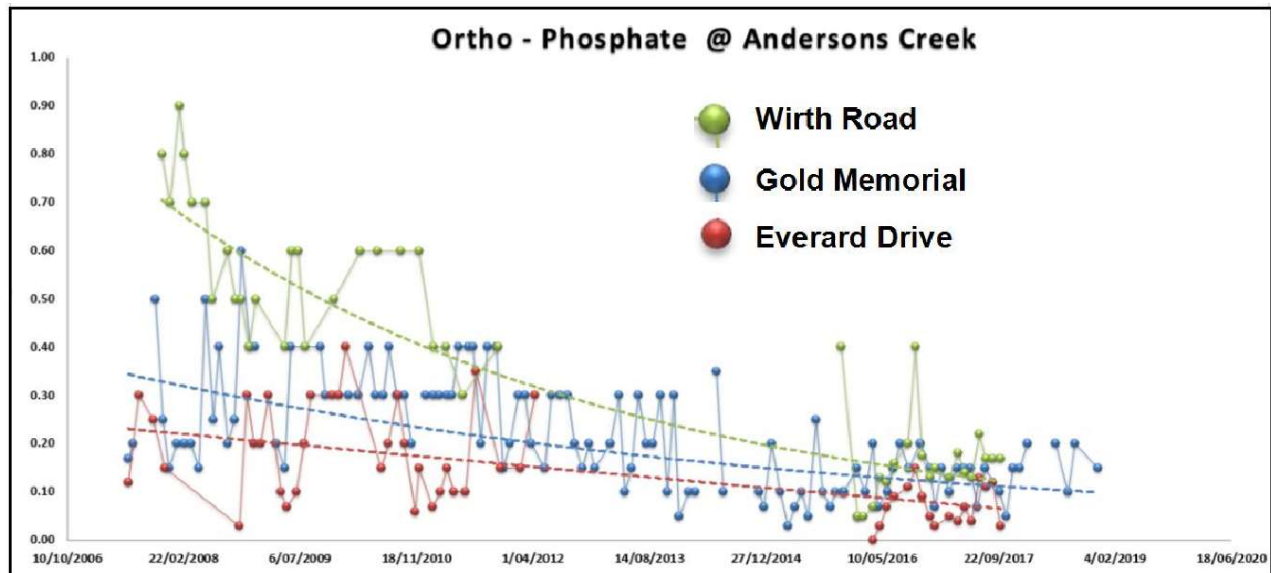
Figure 14. Andersons Creek Ortho-phosphate levels

Waterwatch monitoring in Andersons Creek indicates that the creek is being impacted by highly polluted stormwater discharging from the majority of the stormwater drains. The continuous nature of the stormwater discharge, even outside of rainfall, and the associated milky white colour, strong sewer-like odour and foamy consistency suggests that the discharge is likely to have originated as household waste water. Measurements of Ortho-phosphorus, electrical conductivity and ammonium, particularly in the upper parts of the catchment, are measured as highly degraded and can regularly exceed the limits of the Waterwatch equipment. Waterwatch data indicates that the creek is at its most polluted at the top of the catchment and improves with ground water dilution as the creek flows through the Warrandyte State Park.

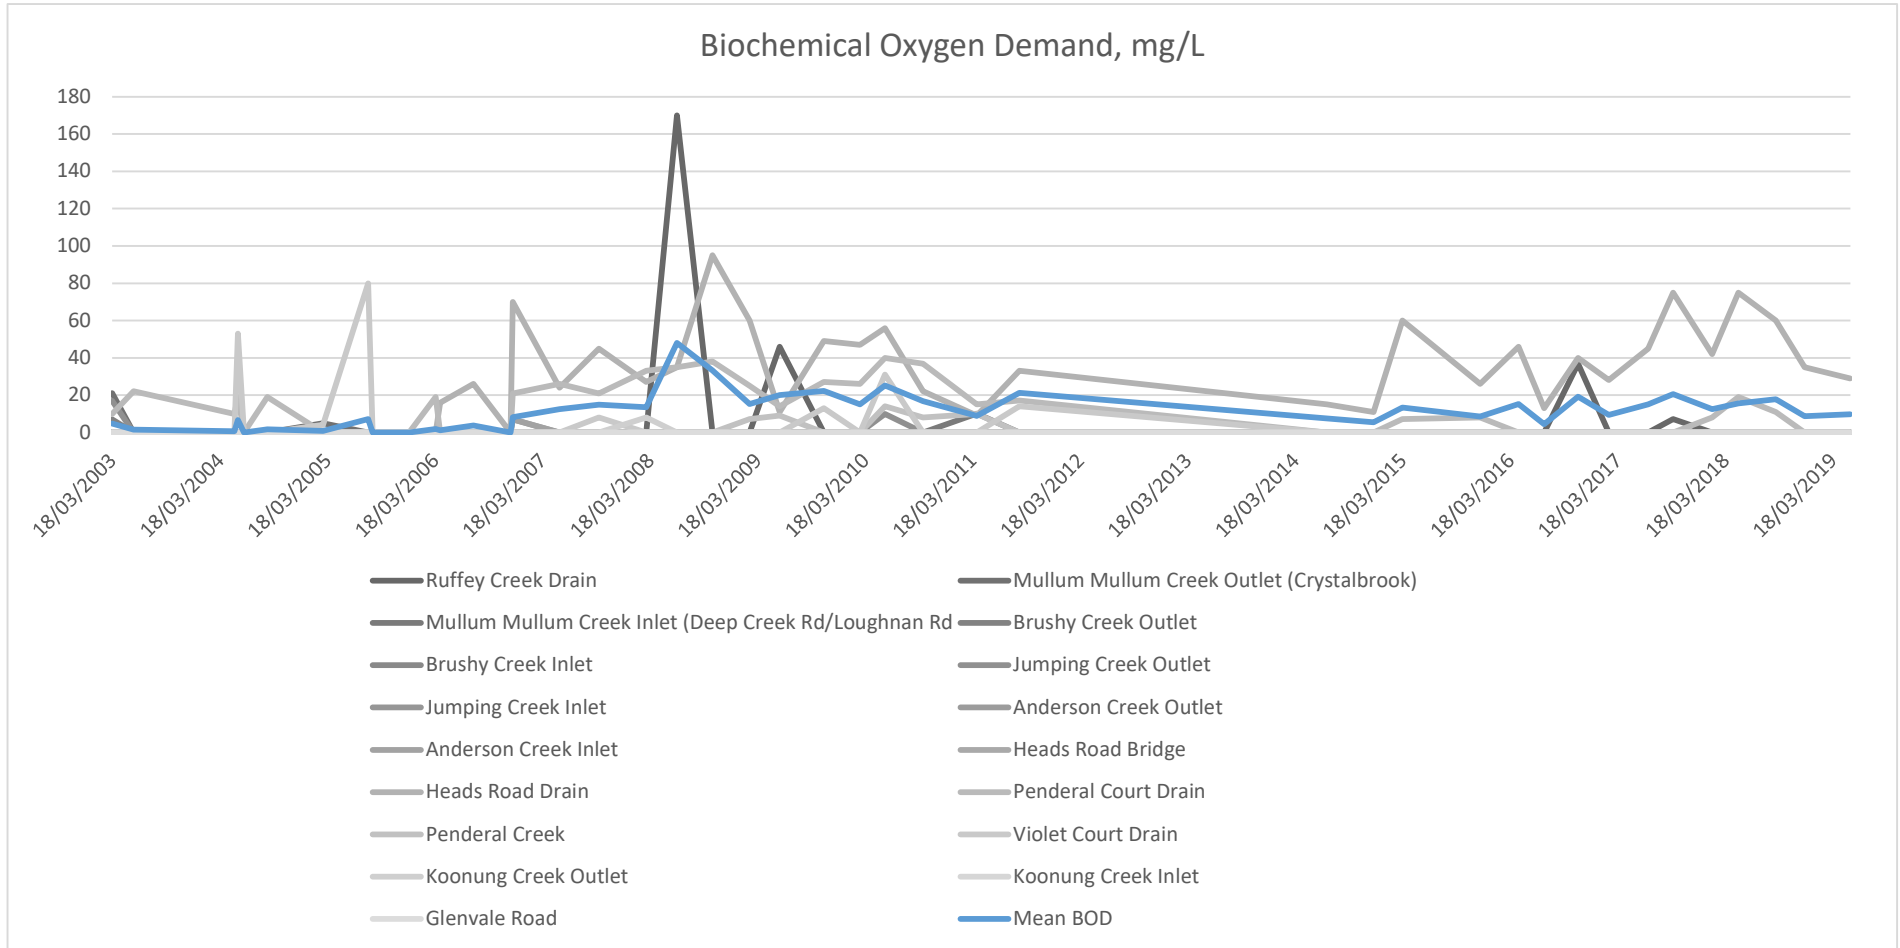
Figure 15: BOD by date and location

Water sampling has been conducted by the DWMP team since 2003 at several locations along creeks running throughout Manningham. Samples were taken 30cm below the surface to obtain a consistent sample representative of the water quality in that area. The table below indicates high levels of E.coli present in Manningham's creeks and is indicative of faecal contamination. In some instances, levels were considerably higher than those levels recommended for swimming.

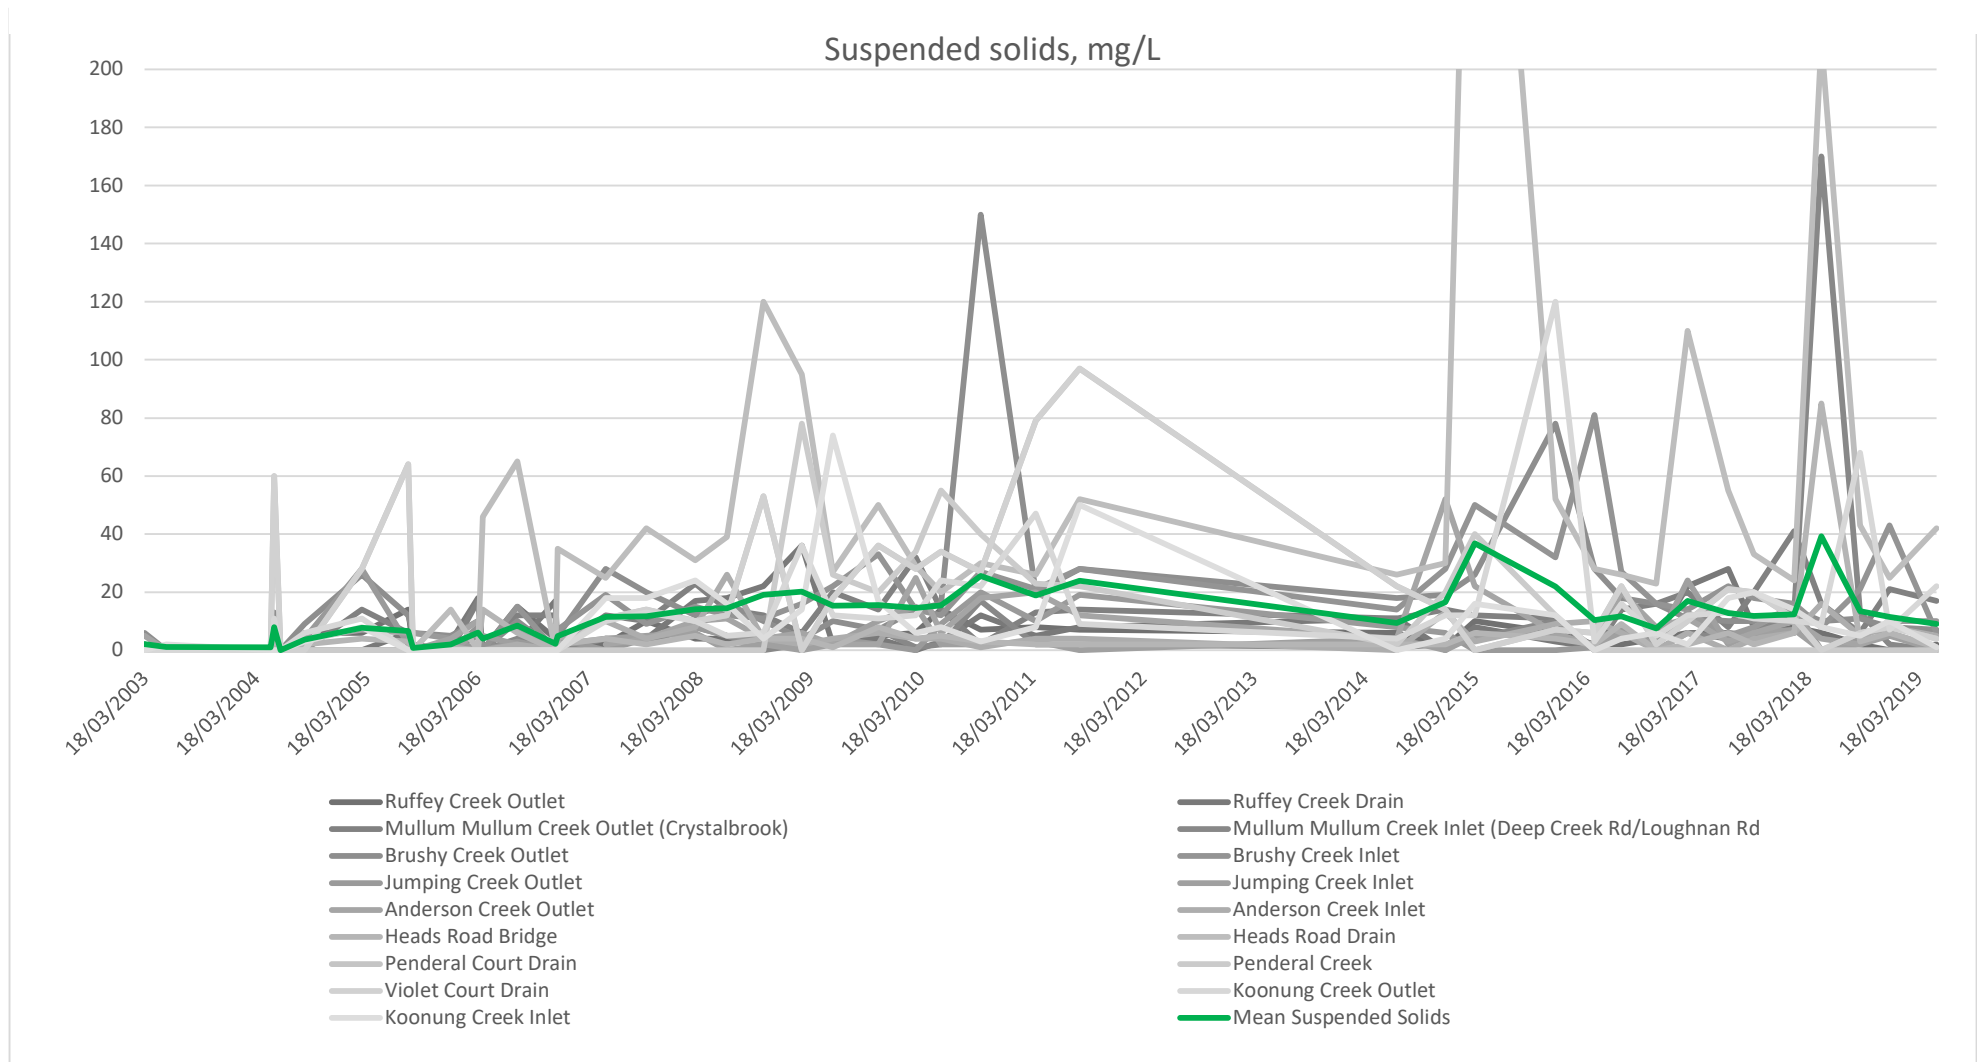
Figure 16: Suspended Solids by date and location

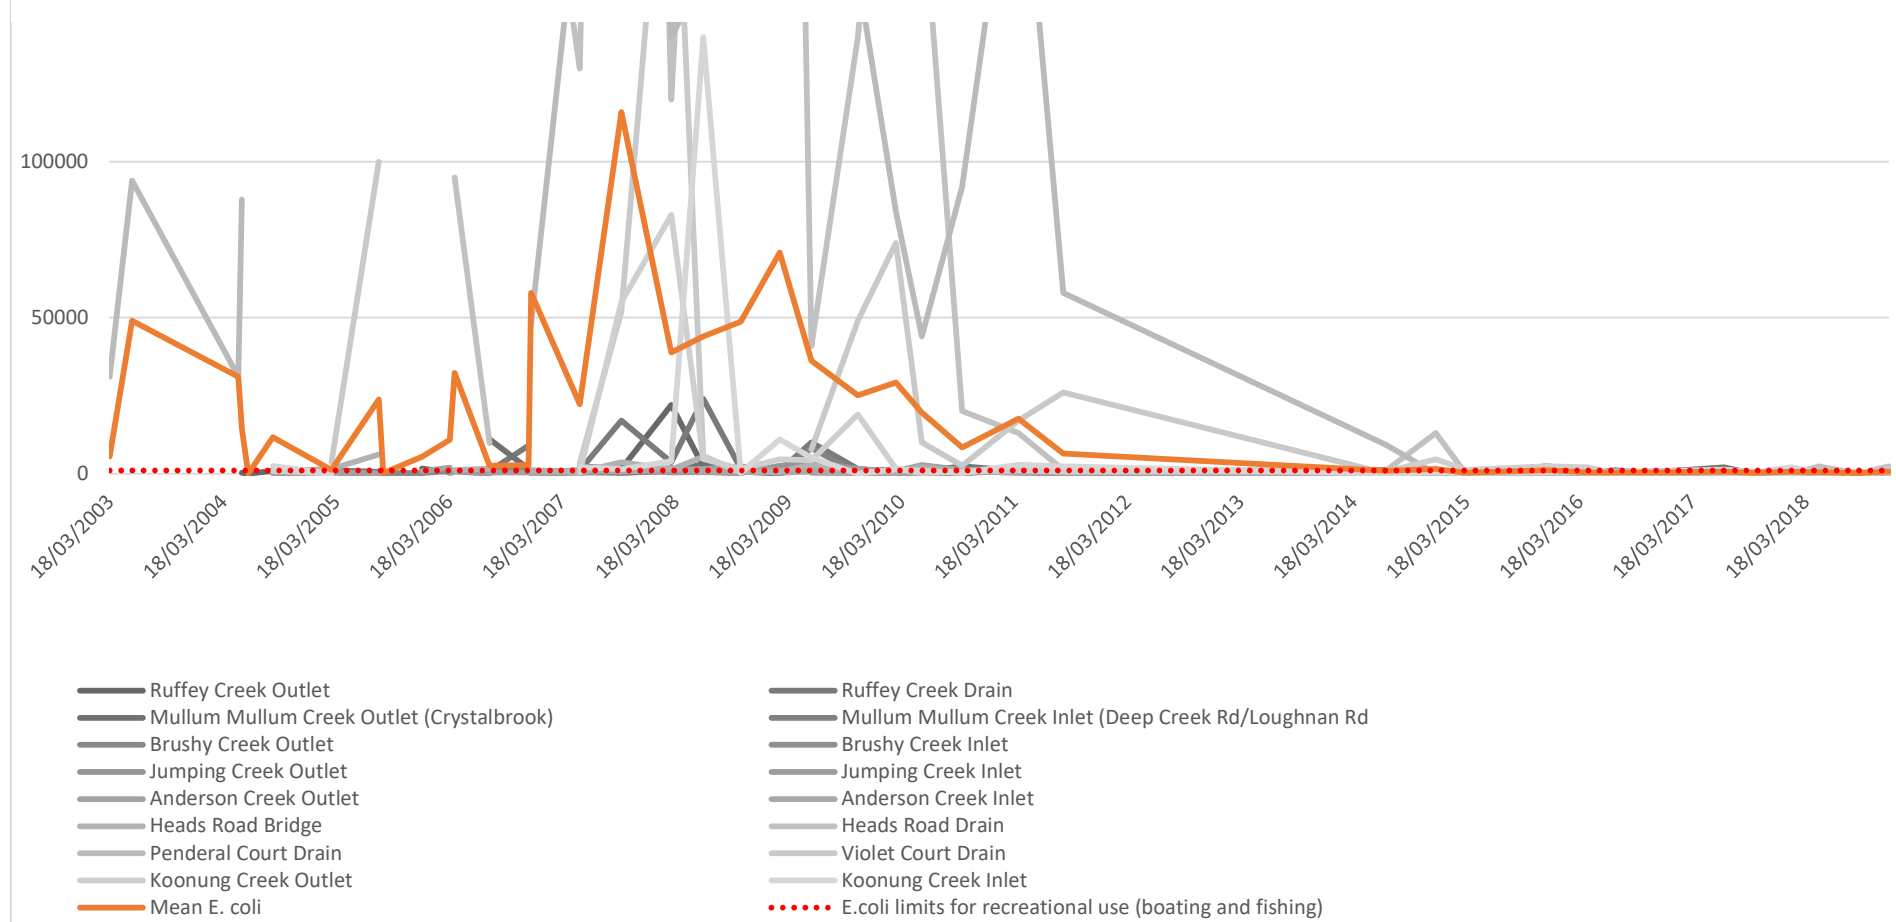
Figure 17: E.coli by date and location

- E.coli levels above 200/100ml are not recommended for swimming
- Levels above 1000/100ml are not recommended for fishing or boating activities.
