# Electric Line Clearance Management Plan 2025-2026

Electricity Safety (Electric Line Clearance)  
Regulations 2020

MANNINGHAM

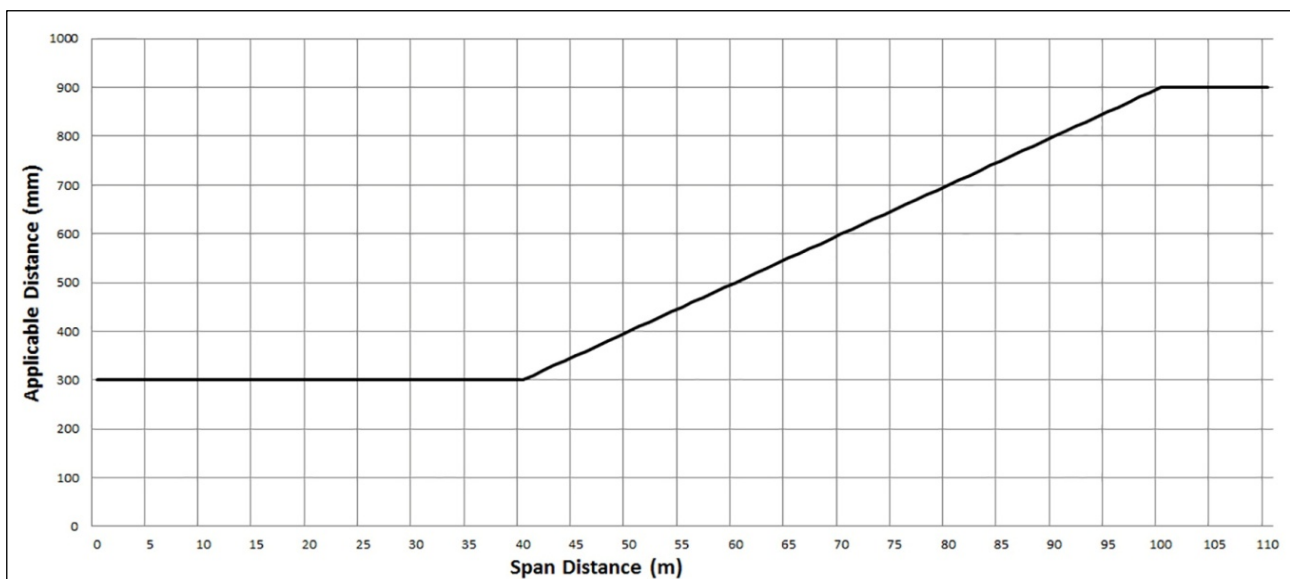
Graph 1: Applicable distance for insulated electric lines in all areas

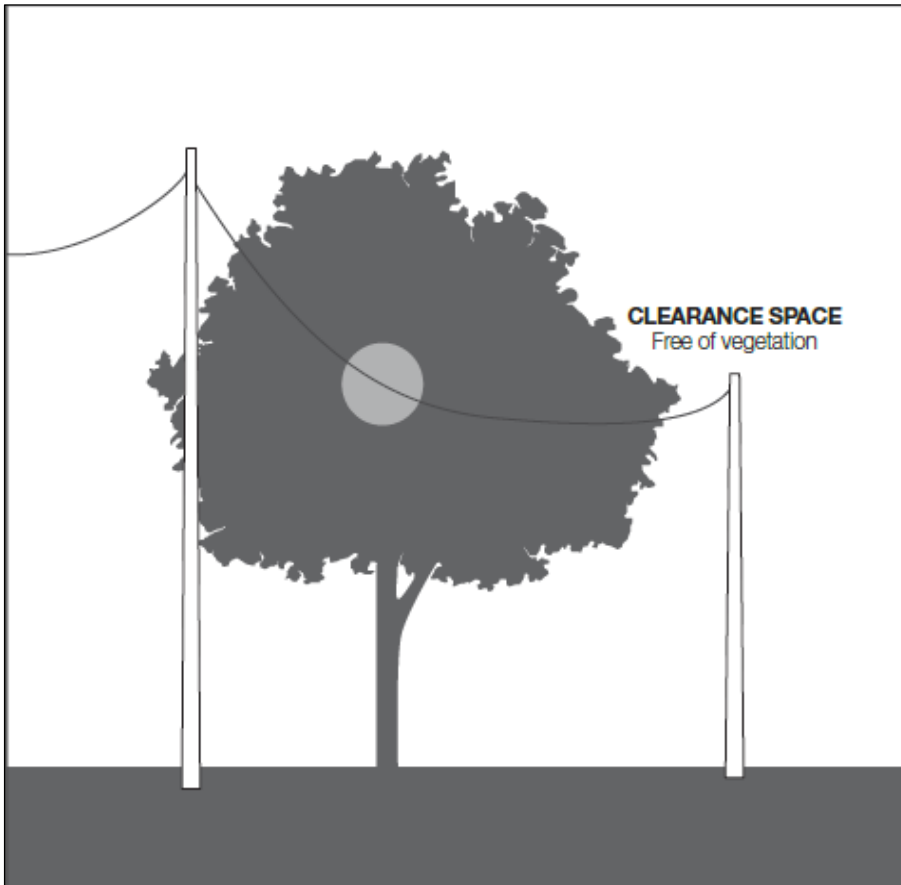
Figure 1: Clearance space for insulated electric lines in all areas

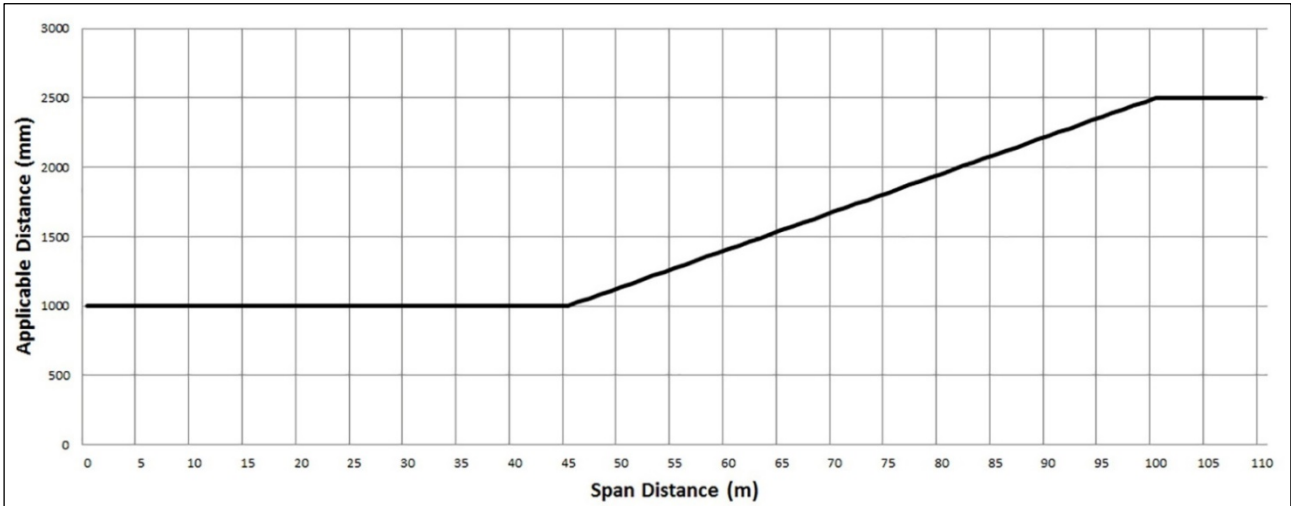
Graph 2: Applicable distance for uninsulated low voltage electric line in a low bushfire risk area

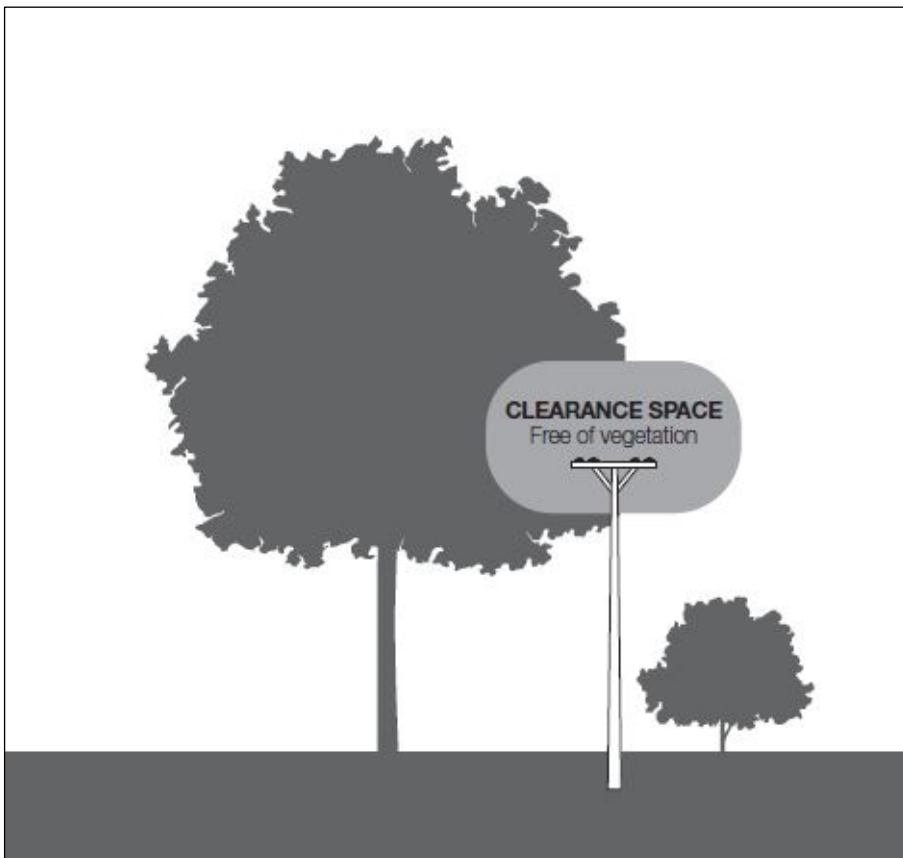
Figure 2: Clearance space for uninsulated low voltage electric line in a low bushfire risk area

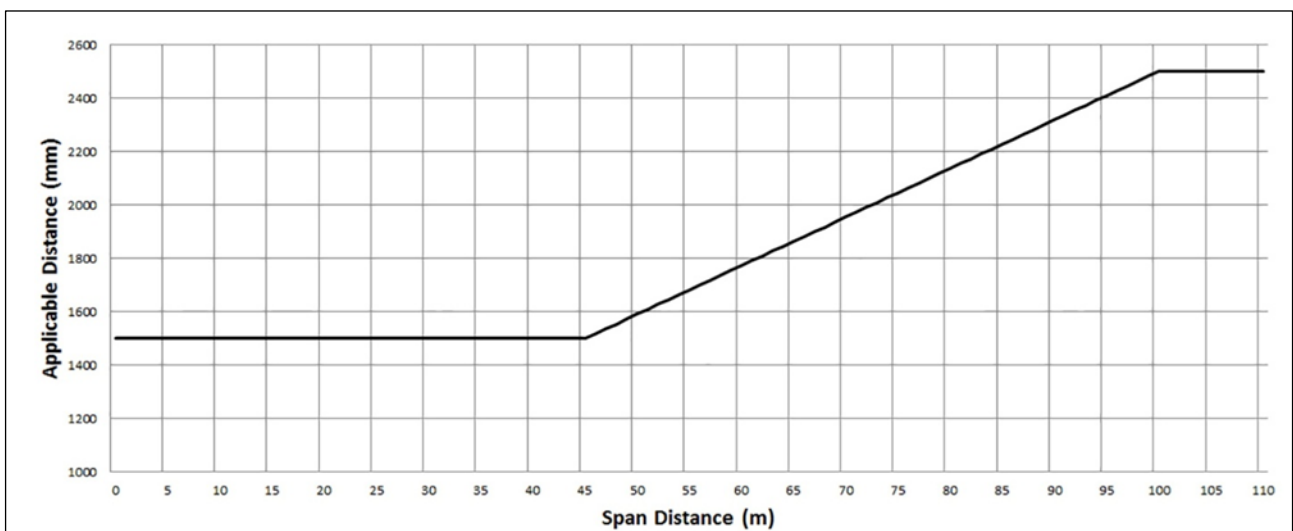
Graph 3: Applicable distance for uninsulated high voltage electric line (other than a 66 000-volt electric line) in a low bushfire risk area

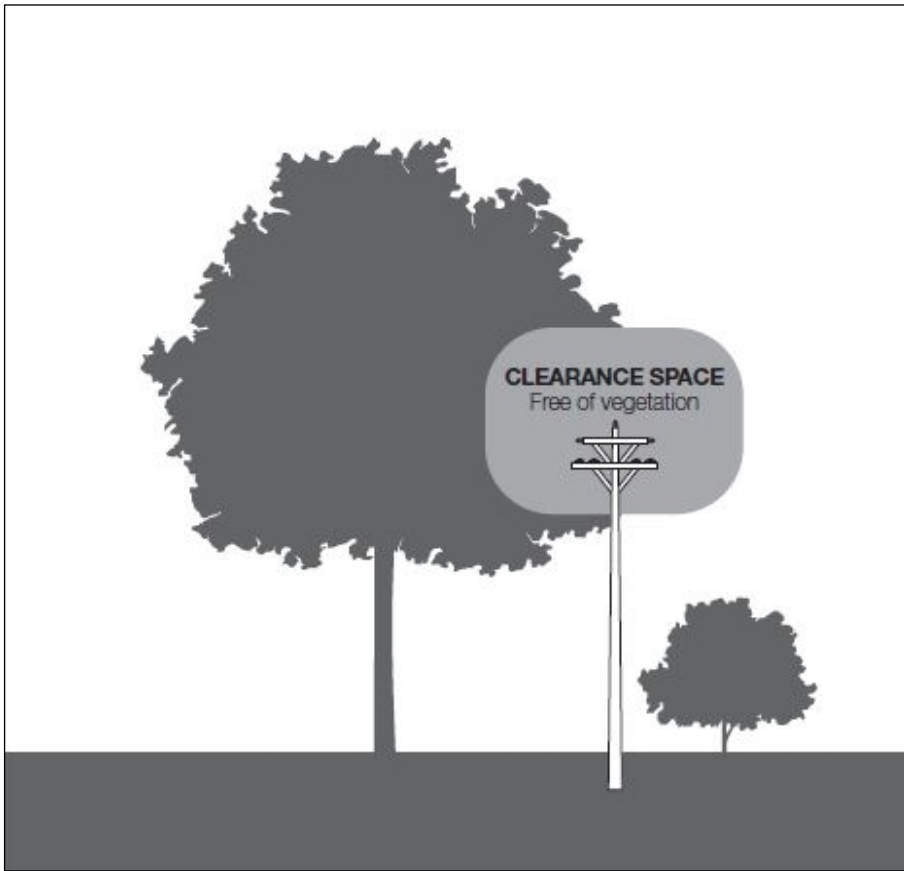
Figure 3: Clearance space for uninsulated high voltage electric line (other than a 66 000 volt electric line) in a low bushfire risk area

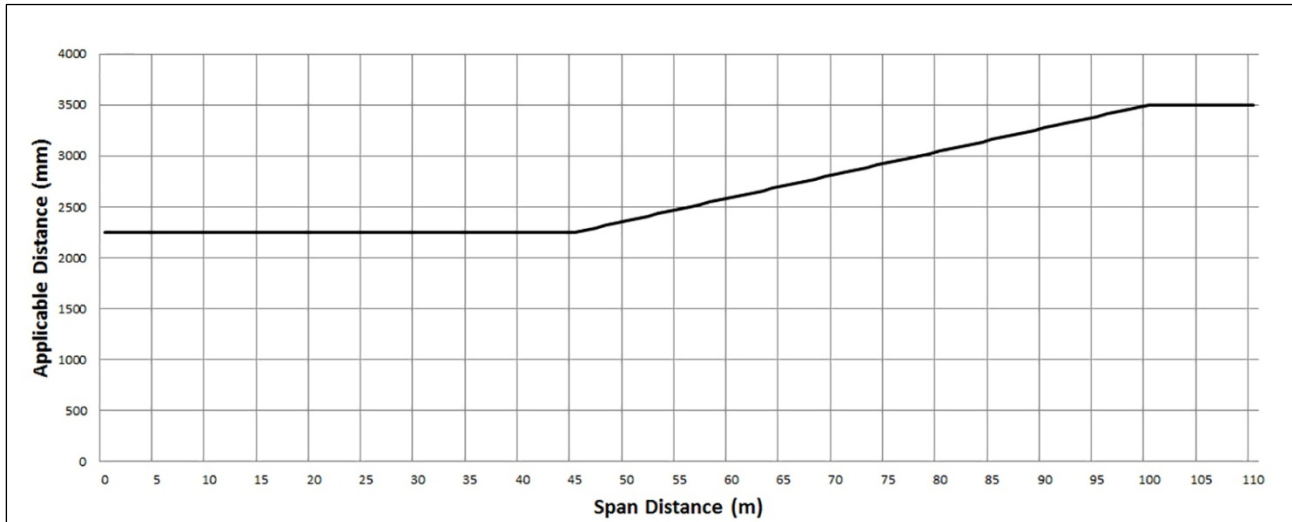
Graph 4: Applicable distance for uninsulated 66 000 volt electric line in a low bushfire risk area

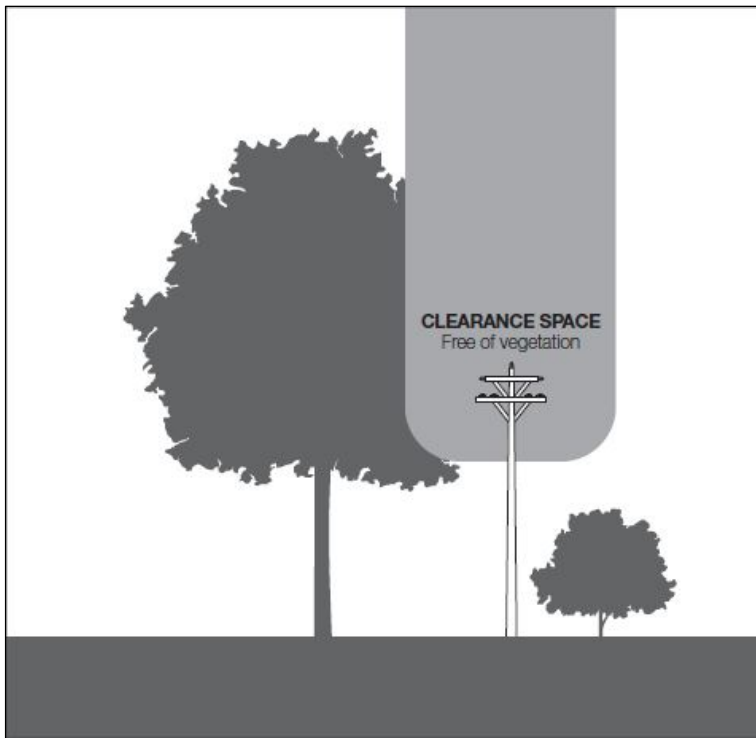
Figure 4: Clearance space for uninsulated 66 000 volt electric line in a low bushfire risk area

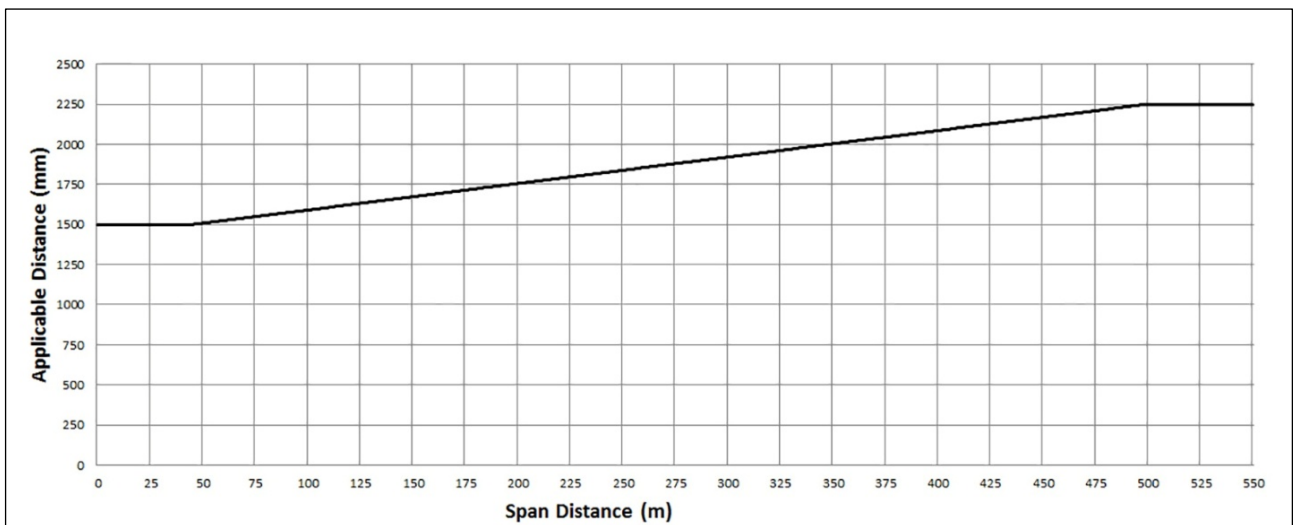
Graph 5: Applicable distance for uninsulated low voltage and high voltage electric line (other than a 66 000 volt electric line) in hazardous bushfire risk area

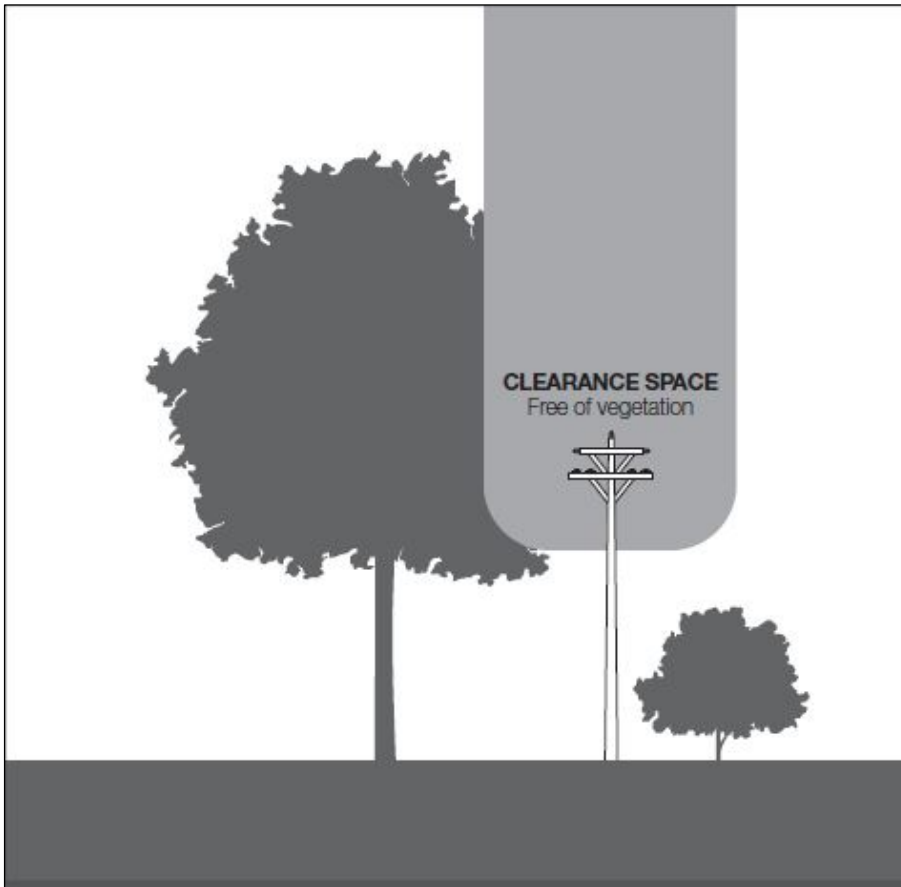
Figure 5: Clearance space for uninsulated low voltage and high voltage electric line (other than a 66 000-volt electric line) in hazardous bushfire risk area

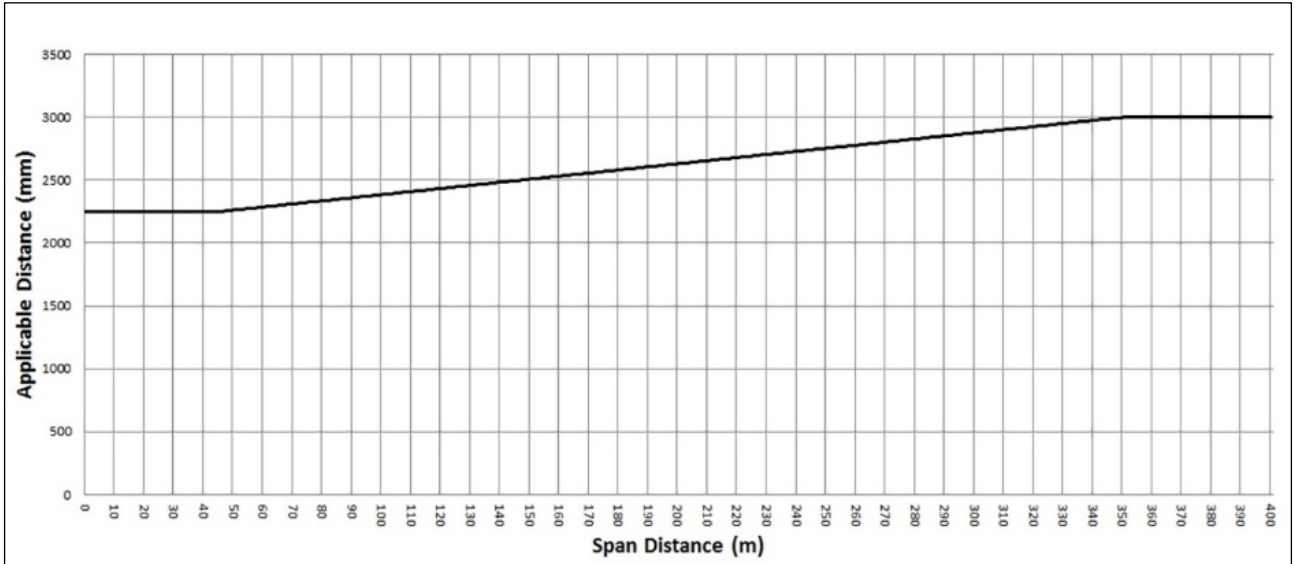
Graph 6: Applicable distance for uninsulated 66 000-volt electric lines in a hazardous bushfire risk area

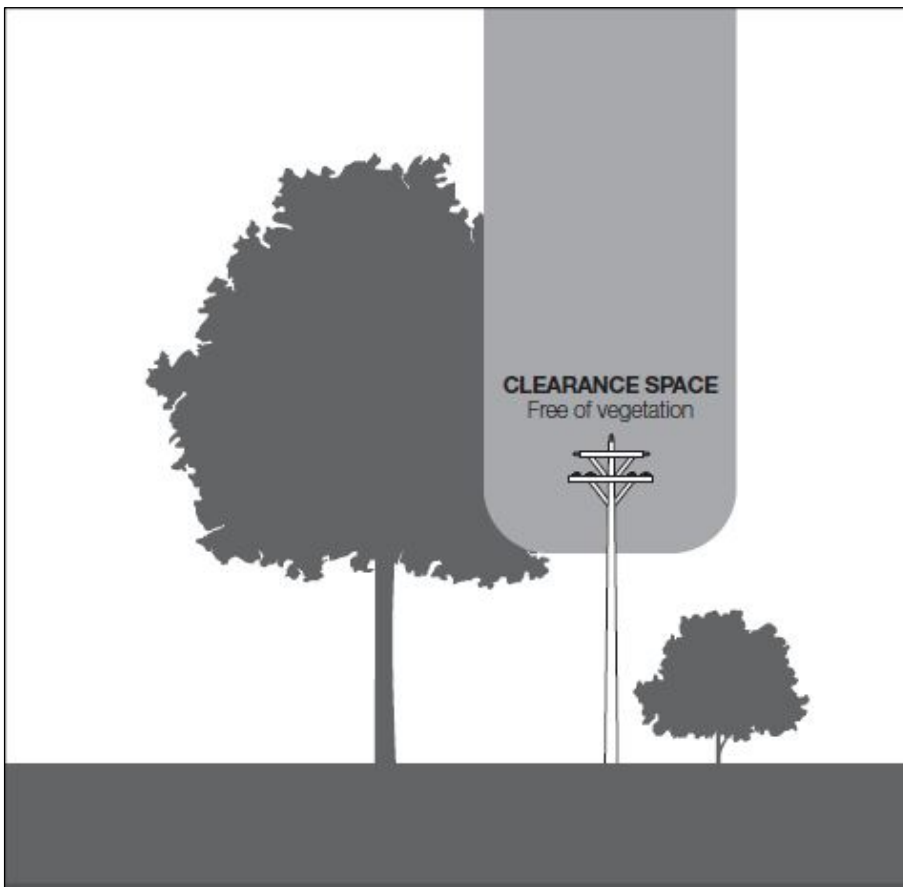
Figure 6: Clearance space for uninsulated 66 000 volt electric lines in a hazardous bushfire risk area
